| Topic | Window Drop Glass Operation Continental GT/GTC 25-26MY |
| Transaction No. | 2080372/2 |

Window Drop Glass Operation | Continental GT/GTC | 25-26MY

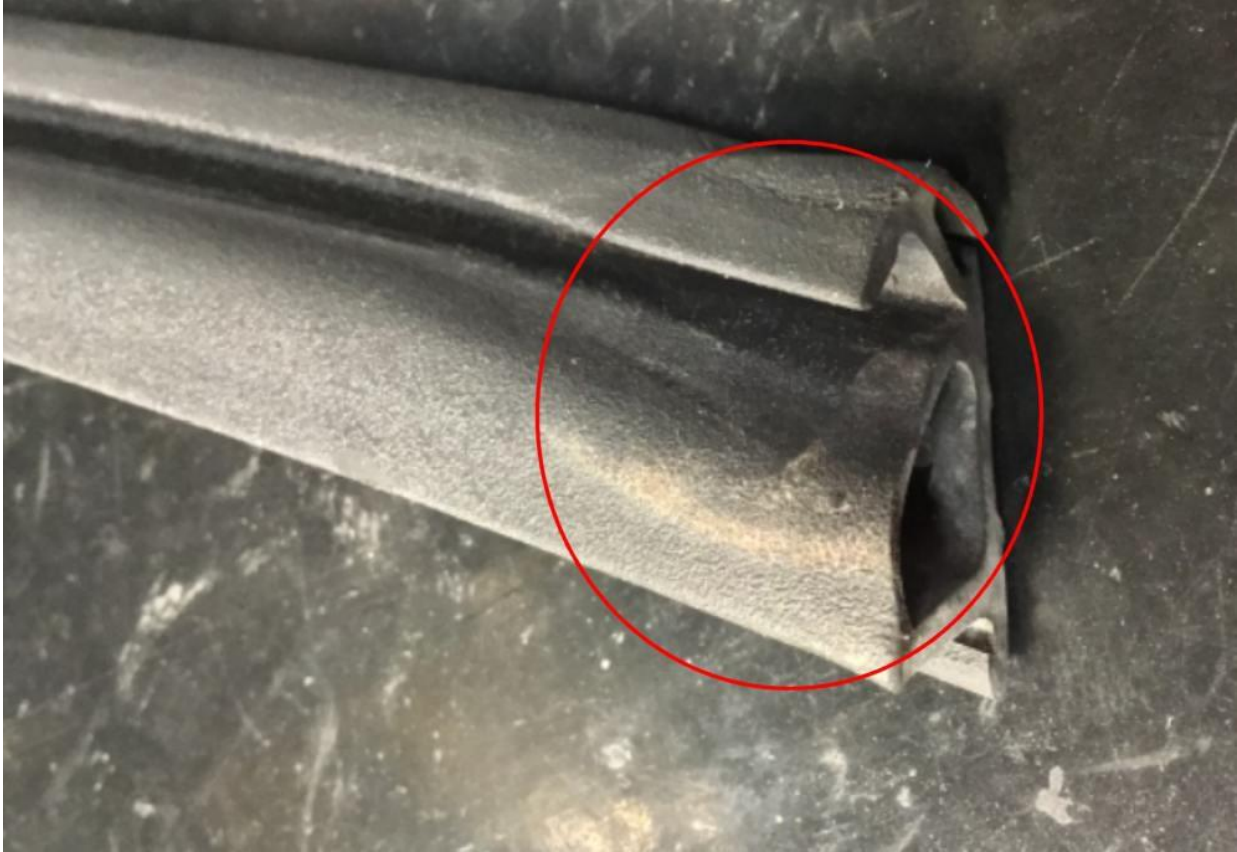
Figure 1

- Incorrectly fitted / located
- Drop glass seal deformation (see Figures 1 and 2 as examples)

NOTE: Any issues found with the window seals must be rectified before conducting the remaining steps
