2027MY  
Telluride Hybrid  
(LQ2 HEV)

116

## TECHNICAL SERVICE BULLETIN

SERVICE ACTION: TRANSAXLE ASSEMBLY  
REPLACEMENT (SA648)

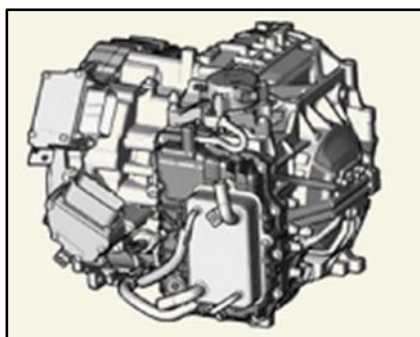
This bulletin provides information to replace the transaxle assembly on certain 2027MY Telluride Hybrid (LQ2 HEV) vehicles produced from February 02, 2026, through March 20, 2026. The affected vehicles may exhibit a rough 3rd → 4th gear upshift and/or 5th → 4th gear downshift accompanied by an illuminated malfunction indicator lamp with DTC P073500 stored. Follow the procedure outlined in this publication to replace the transaxle assembly on the applicable vehicle. Before conducting the procedure, verify that the vehicle is included in the list of affected VINs.

P073500 - Gear 5 Incorrect Ratio - No Sub Type Information
