## Technical product information

| <b>Topic</b> | Window Drop Glass Operation Continental GT/GTC 19-24MY |
| <b>Transaction No.</b> | 2080375/3 |

Window Drop Glass Operation | Continental GT/GTC |19-24MY

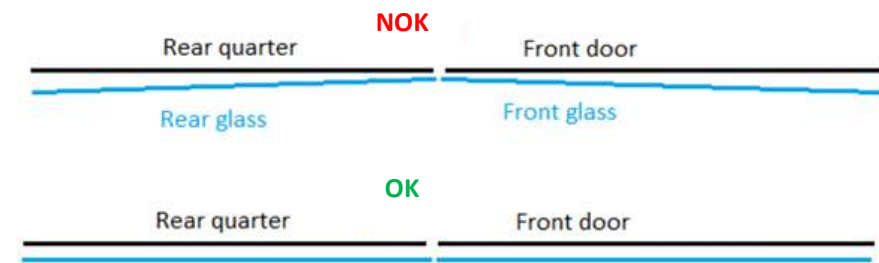
See image below, for OK and NOK after  
adjustment/checking

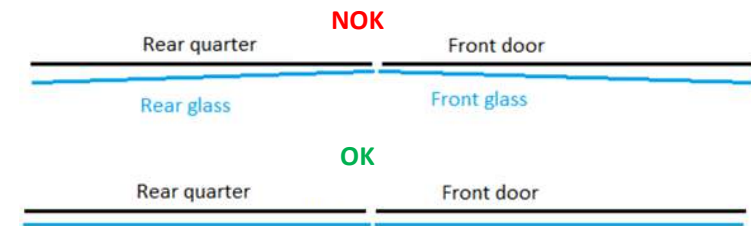
See image below, for OK and NOK after adjustment/checking
