## Technical product information

| <b>Topic</b> | Window Drop Glass Operation Continental GT/GTC 25-26MY |

Transaction No.: **2080372/3**

Window Drop Glass Operation | Continental GT/GTC | 25-26MY

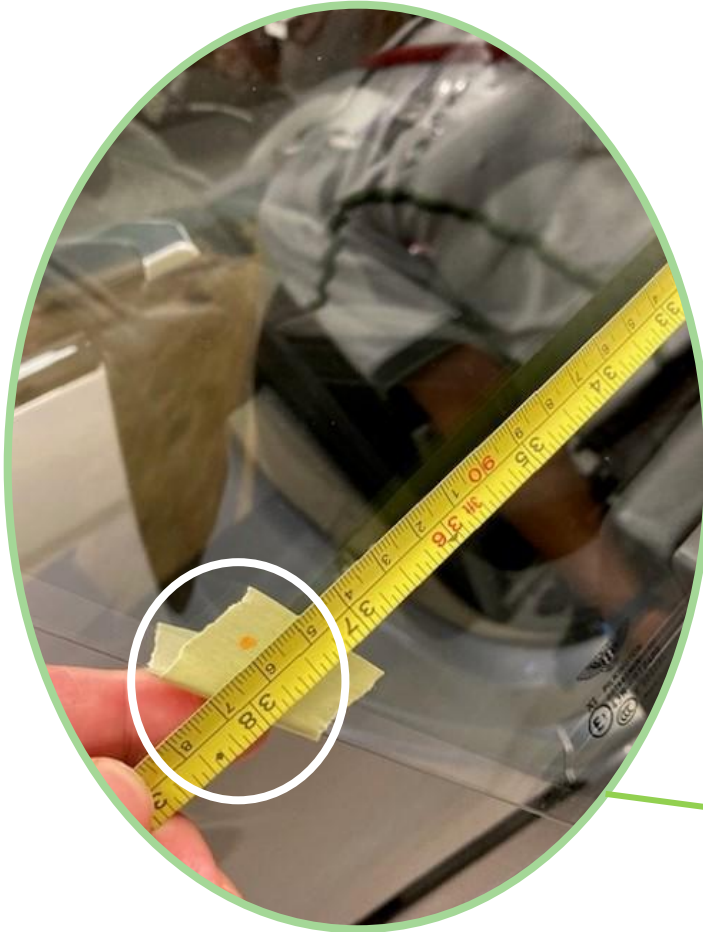
**Specification**  
971mm +2mm

If out of specification, refer to the next slide to adjust the glass position
