| Model(s) | Year(s) | VIN Range | Vehicle Specific Equipment |
| e-tron | 2019<br>2021 – 2023 | All | Not applicable |
| Q8 e-tron, Q8 Sportback e-tron, SQ8 e-tron, and SQ8 Sportback e-tron | 2024 | | |

| <b>Claim Comment:</b> | As per TSB 2073858/12 | | |

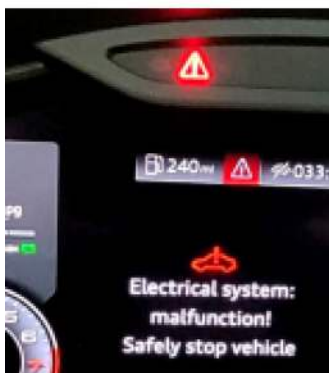
- A Drive System/Electrical System Malfunction message (Figure 1) appears in the instrument cluster.

**Figure 1.** Warning lamp associated with message.

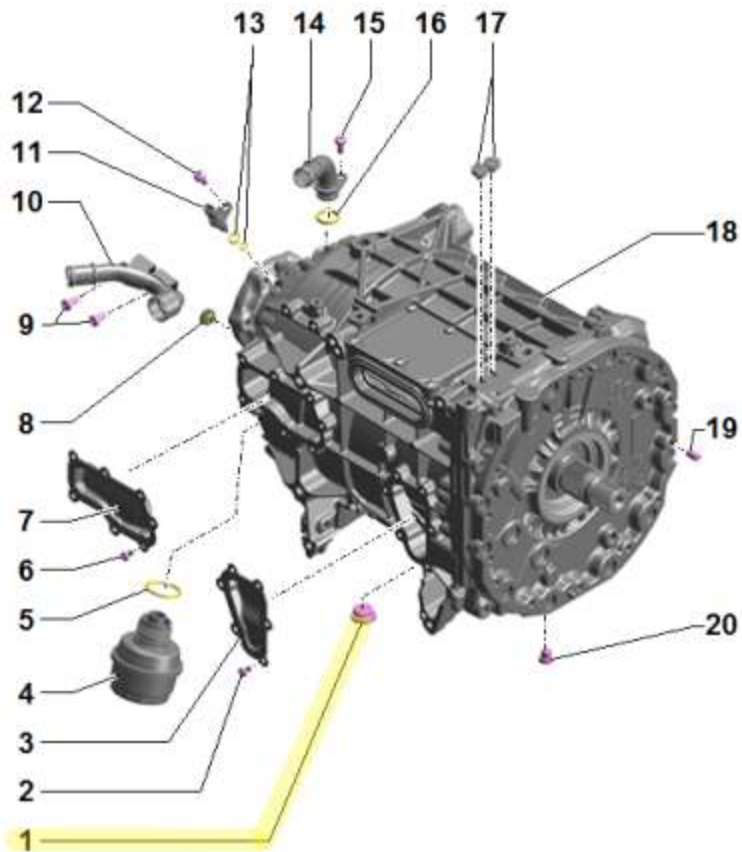
**Rear axle (Figure 2):**

Drip container is overflowing:

- Coolant leaking from active chamber.

Drip container is empty:

- Coolant leaking from active chamber, particularly on vehicles with low mileage.

**Figure 2.** (1) Drain plug.
