| <b>HYUNDAI</b><br><b>Technical Service Bulletin</b> | GROUP<br><b>FUEL SYSTEM</b> | NUMBER<br><b>26-FL-003H</b> |
| | DATE<br><b>JUNE 2026</b> | MODEL(S)<br><b>KONA (SX2)</b> |
| <b>SUBJECT:</b> FALSE “ENGINE LEFT IDLING” MYHYUNDAI NOTIFICATIONS - ECM SOFTWARE UPDATE - DTC P223700 | | |

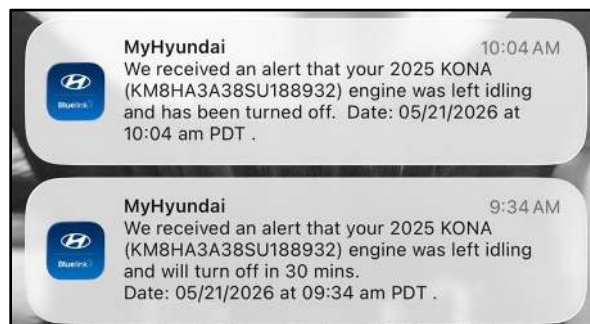
**Description:** Some Kona (SX2) vehicles equipped with the 1.6L T-GDI engine may exhibit false “engine left idling” notifications in the MyHyundai app, even when the engine is not running, due to a logic error associated with the front oxygen (O<sub>2</sub>) sensor. This condition may also illuminate the Malfunction Indicator Lamp (MIL) and set DTC P223700 (O<sub>2</sub> Sensor Pumping Current Circuit/Open [Bank 1 Sensor 1]). This bulletin provides instructions to perform an ECU software update to correct the O<sub>2</sub> sensor logic and resolve the condition.

Sample MyHyundai App Notifications
