| <br>PARTS & SERVICES | | <b>Technical Service Bulletin (TSB)</b><br><b>Global Telematics Box (TBM) Firmware Over</b><br><b>The Air (FOTA) Update To SW 4.39</b> | | | |
| <b>REFERENCE:</b> | <b>TSB:</b> 08-265-26<br><b>GROUP:</b> 08 - Electrical | <b>Date:</b> | July 3, 2026 | <b>REVISION:</b> | — |
| <b>VEHICLES AFFECTED:</b> | <b>2026 (WD) Dodge Durango</b><br>This bulletin applies to vehicles built on or before July 20, 2026 (MDH 0720XX) equipped with Global Telematics Box Module (Sales Code RDG). | | | <b>MARKET APPLICABILITY:</b><br><div><input checked="" type="checkbox"/> NA<input type="checkbox"/> MEA</div> <div><input type="checkbox"/> SA<input type="checkbox"/> IAP</div> <div><input type="checkbox"/> EE<input type="checkbox"/> CH</div><br><b>NOTE:</b> This bulletin applies to the North America market. | |

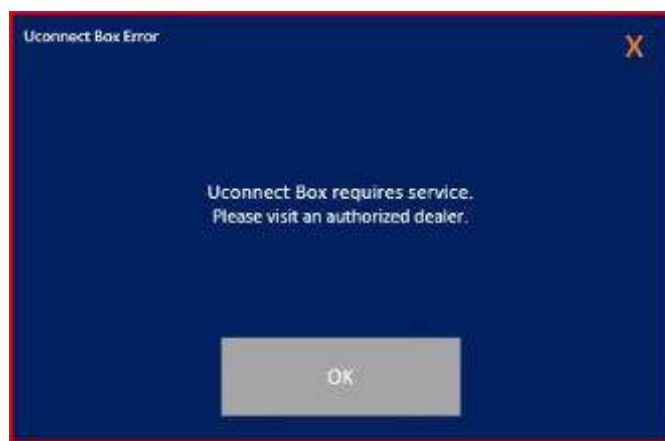
**Fig. 1**

Uconnect Box Error Message

Message display on the radio screen "Uconnect Box requires service. Please visit an authorized dealer." [Fig. 1.](#)

This bulletin provides information regarding the latest Firmware Over The Air (FOTA) update and provides the service technician an overview of the steps a customer will need to take to complete the update. The TBM software will be updated from 4.38 to 4.39 (243187 SW PN number).

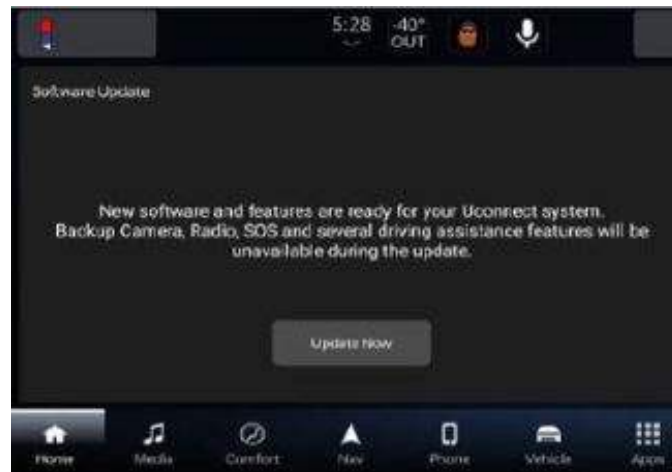
**Fig. 2**

Software Acceptance Screen

1. The vehicle needs to be in 'Park'. The ignition needs to be in the off position.
2. If the customer selects “Update Now” [Fig. 2](#), they can shut off the vehicle and leave. The update will be completed automatically.

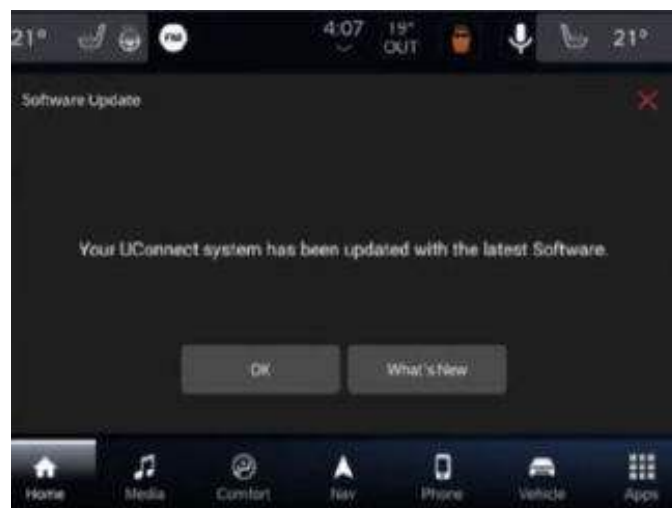
**Fig. 3**

Software Update Confirmation Screen

3. Upon completion of update, the radio will display a confirmation message [Fig. 3](#).
