**Technical Service Bulletin (TSB)**  
**Engine Runs Rough**

| REFERENCE: | TSB: 09-013-26<br>GROUP: 09 - Engine | Date: | July 10, 2026 | REVISION: | — |
| VEHICLES AFFECTED: | 2026 (WL) Jeep Grand Cherokee / Grand Cherokee L<br>This bulletin applies to vehicles built on or before July 02, 2026 (MDH 0702XX) equipped with the 2.0L Hurricane 4 Turbo W/ESS (Sales Code EC7). | | | MARKET APPLICABILITY:<br><div><input checked="" type="checkbox"/> NA<input type="checkbox"/> MEA</div> <div><input type="checkbox"/> EE<input type="checkbox"/> IAP</div> <div><input type="checkbox"/> SA<input type="checkbox"/> CH</div><br>NOTE: This bulletin applies to North America markets. | |

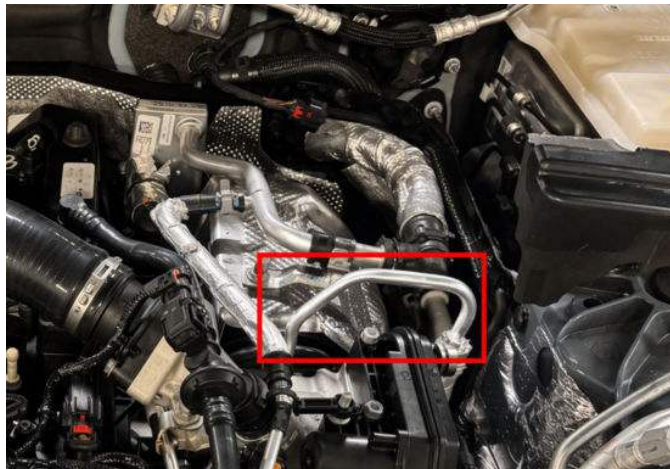
**Fig. 1**

**Do not to grab or lean on the turbo oil feed line. Doing so can damage the tube Fig. 1.**

Turbo Oil Feed Line
