**Technical Service Bulletin (TSB)**  
**High Pressure Fuel Pump**

| REFERENCE: | TSB: 14-002-26 REV. A<br>GROUP: 14 - Fuel System | Date: | July 8, 2026 | REVISION: | 14-002-26 |
| VEHICLES AFFECTED: | 2022 - **2027** (B1) Jeep Renegade<br>2022 - **2027** (H1) Jeep Commander<br>2022 - **2027** (M1) Jeep Compass<br>This bulletin applies to vehicles equipped with a 1.3 I4 Turbo MAIR DI Engine (Sales Code EYJ). | | | MARKET APPLICABILITY:<br><div><input type="checkbox"/> NA<input type="checkbox"/> MEA</div> <div><input checked="" type="checkbox"/> SA<input type="checkbox"/> IAP</div> <div><input type="checkbox"/> EE<input type="checkbox"/> CH</div><br>NOTE: This bulletin applies to the Brazilian market. | |

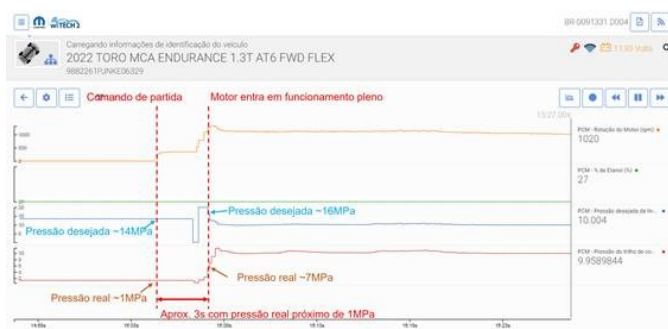
**Fig. 1**

Graphical Mode - KO Result

8. Monitor wiTECH whether the high-pressure fuel pump will deliver the desired pressure immediately at the time of start-up when the failure occurs:
9. Is there a delay in the pressure increase or does the actual pressure not reach the desired pressure?

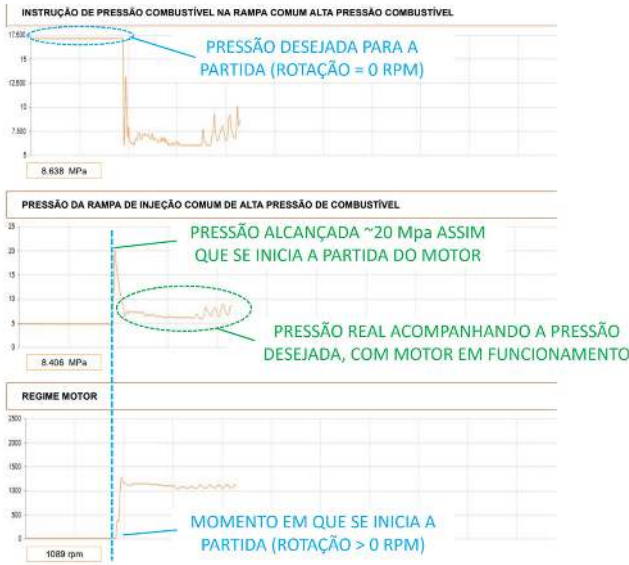
**Fig. 3**  
Engine Start Without Failure

Partida do motor de um veículo **SEM** falha
