## Technical Service Bulletin (TSB)

### High Pressure Fuel Pump

| REFERENCE: | TSB: 14-008-26<br>GROUP: 14 - Fuel System | Date: | July 8, 2026 | REVISION: | — |
| VEHICLES AFFECTED: | 2022 - 2027 (B1) Jeep Renegade<br>2022 - 2027 (H1) Jeep Commander<br>2022 - 2027 (M1) Jeep Compass<br>This bulletin applies to vehicles equipped with a 1.3L I4 Turbo MAir DI Engine w/ESS (Sales Code EYF) or 1.3L I4 Turbo MAir DI Engine (Sales Code EYH). | | | MARKET APPLICABILITY:<br><div><input type="checkbox"/> NA<input type="checkbox"/> MEA</div> <div><input checked="" type="checkbox"/> SA<input type="checkbox"/> IAP</div> <div><input type="checkbox"/> EE<input type="checkbox"/> CH</div><br><b>NOTE:</b> This bulletin applies to the South America market and excludes the Brazilian market. | |

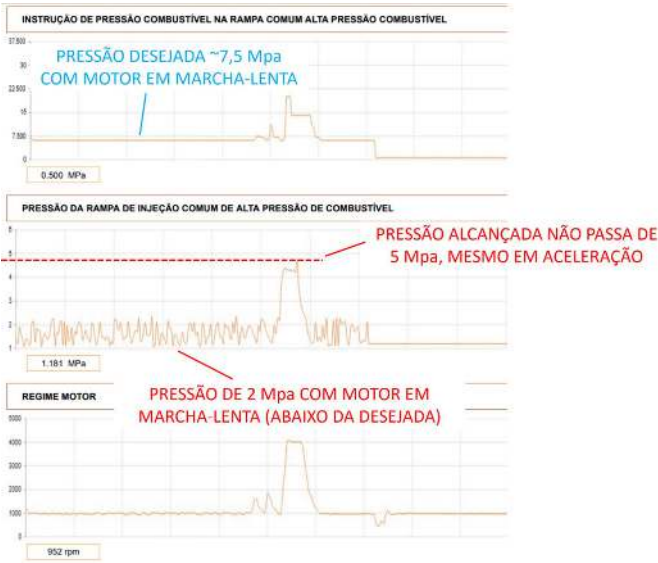
**Fig. 2**  
Engine Start With Failure

- If the pressure measured on the pressure gauge **is between 5.2 and 6.0 bar**, but the rail pressure (injector ramp) measured does NOT follow the desired pressure in the parameters via wiTECH, take a screenshot or PDF print of the screen demonstrating the incident and proceed to **REPAIR PROCEDURE**.

Partida do motor de um veículo **COM** falha

1. Replace the high pressure fuel pump. Refer to the detailed service procedures available in DealerCONNECT/Service Library under: Service Info>1056F72 - Bomba de Pressão - Remoção/Recolocação.
2. Delete the DTCs recorded in the ECM control panel's memory with wiTECH.
3. Perform injector learning with wiTECH.

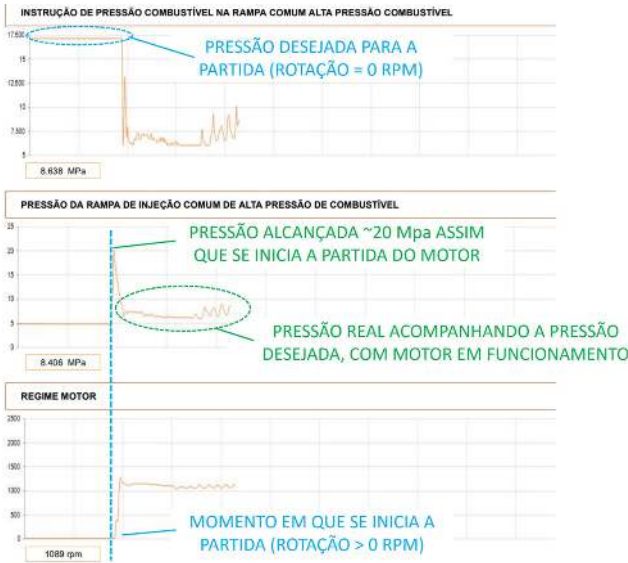
**Fig. 3**  
Engine Start Without Failure

Partida do motor de um veículo **SEM** falha
