2026-2027MY  
Sportage, Sportage Hybrid,  
Sportage Plug-In Hybrid  
(NQ5, NQ5 HEV, NQ5 PHEV)

429

July 2026

CUSTOMER ACTION: UPPER ACTIVE AIR FLAP DUCT  
ASSEMBLY REPLACEMENT (CA2606)

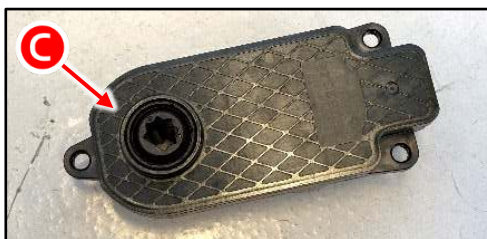
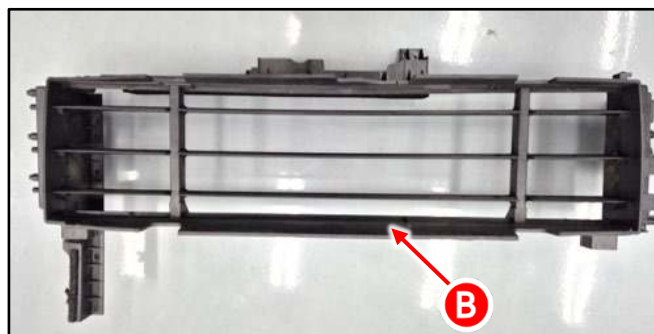
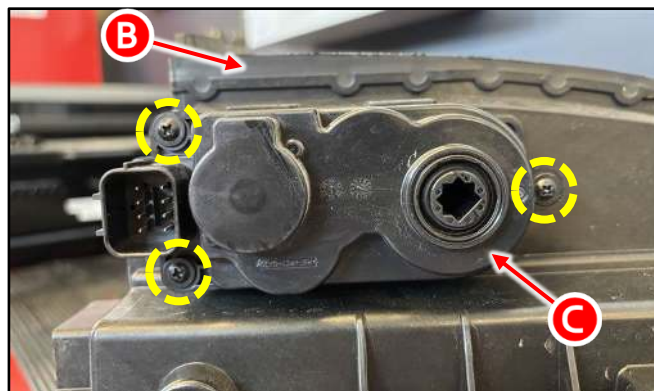
**Note:** The 'new' AAF replacement part (86958 CH500QQK) does NOT include the following parts:

- AAF Actuator (C) (Qty. 1)
- AAF Sensors (D) (Qty. 3)

- Place the removed AAF assembly (B) on top of a clean table.
- Loosen the three (3) retaining screws to remove the existing AAF actuator (C) from the removed AAF assembly (B) and install it onto the new AAF part in the reverse order of removal.
