| Topic | DTC P096C00 and / or P096F00 evident within the Engine Control Module |
| Brand | Bentley |
| Transaction No. | 2075941/4 |

### Bentayga Series - V8 Kovomo

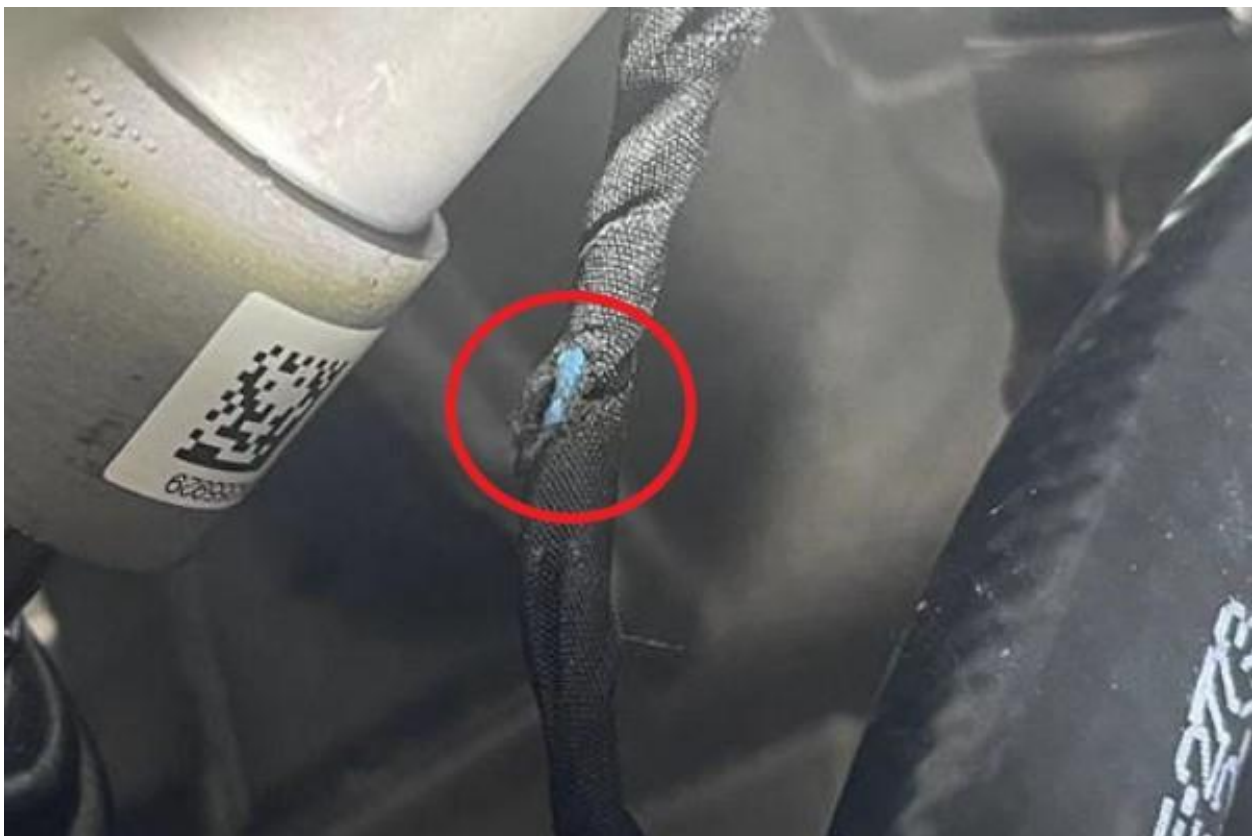
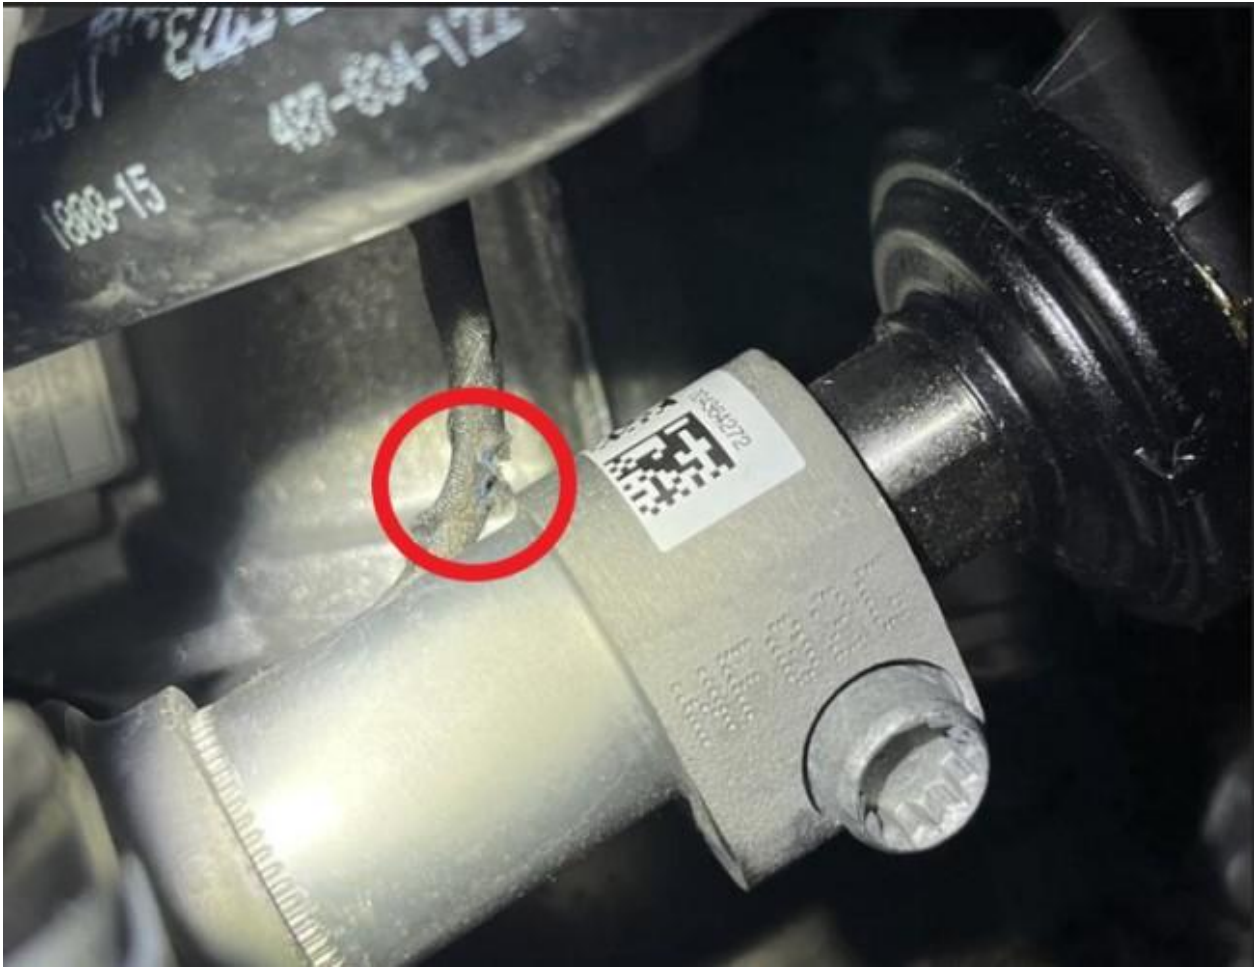
- P096C00 Transmission coolant valve electrical malfunction

- P096F00 Transmission coolant valve short circuit to ground

2) Referring to Figures 1, 2 and 3 - Conduct a visual inspection to confirm if the harness shown (CIRCLE) has any damage relating to contact with the steering shaft .

3) Referring to Rep.Gr 97 - Wiring harness repairs - Repair the damaged wiring using the VAS 1978B wiring repair kit
