## Technical product information

**2068946/12**

Dynamic ride system warning visible - DTC P0B2500 logged within address 0021  
(Battery Energy Control Module 2)

Release date: 16 Jul  
2026

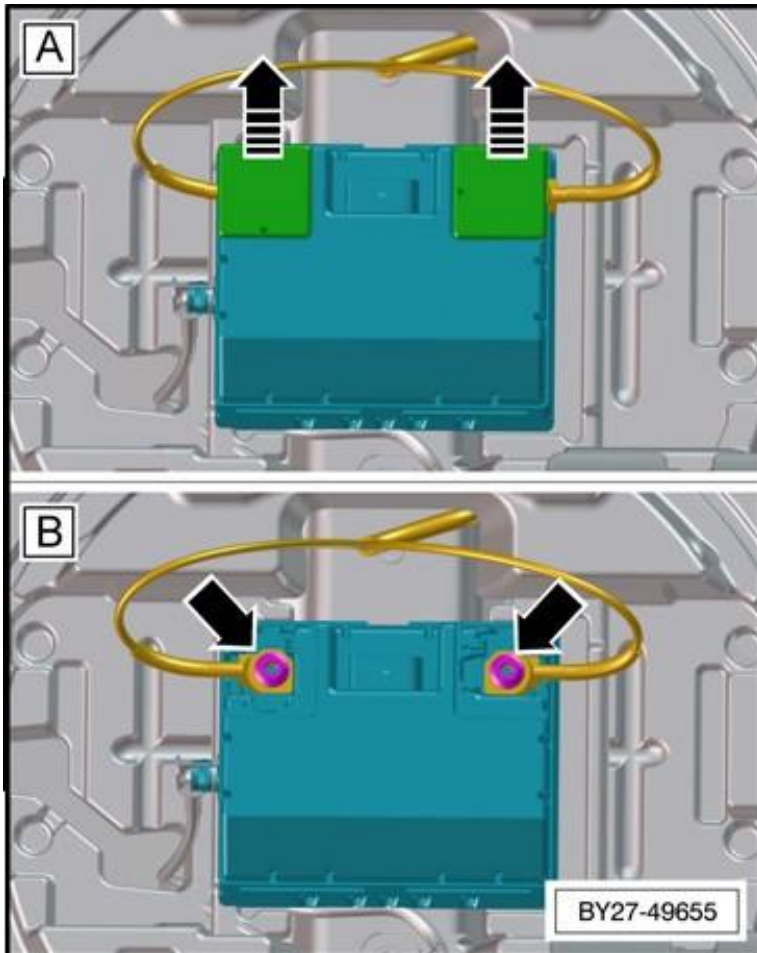
Figure 1

- 1) Referring to Rep.Gr 27 - Deactivate the 48 volt system - Refer to 48 volt system - To activate and deactivate
- 2) Referring to Rep.Gr 27 - Check the security of the super capacitor positive and negative terminals (Figure 1) as follows:
  - Remove the caps (A) from the terminals
  - Check the security of the positive and negative terminals (B) are as described within Rep.Gr 27

- In the event that one or both terminals were not tightened to the correct torque as Rep.Gr 27, the operative must tighten the terminal(s) to the correct torque as detailed within Rep.Gr 27 - Super capacitor

**In the event one or both terminals required tightening to the correct torque (found to be not initially secure) the operative must feedback the findings via DISS**

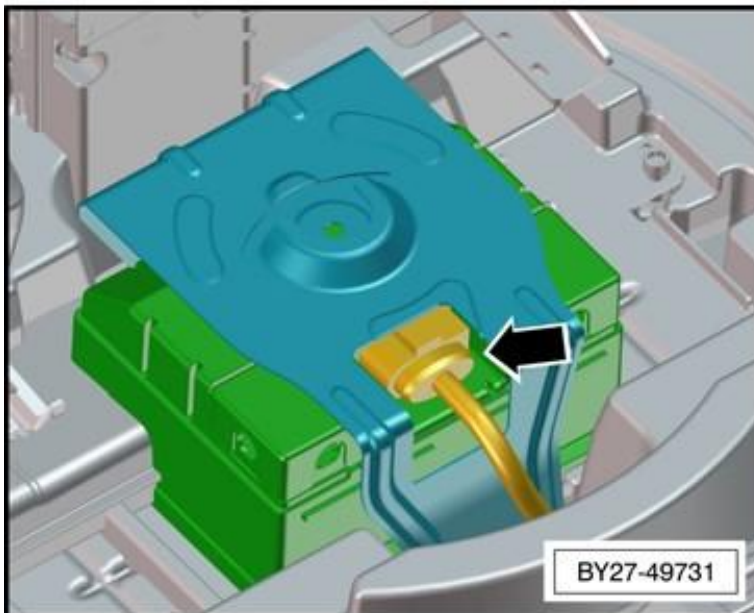
3) Referring to Figure 2 - Check the security of the harness connector

- In the event the harness connector is not secure the operative must secure the connector

**Should an issue be identified with the connector or super capacitor which doesn't allow the connector to be secured the operative must feedback via DISS**
