**Technical Service Bulletin (TSB)**  
**Telematics Box Module (TBM) Firmware Over The Air (FOTA) Software Updating from 4.37 Or 4.38 To 4.39**

| REFERENCE: | TSB: 08-294-26<br>GROUP: 08 - Electrical | Date: | July 25, 2026 | REVISION: | — |
| VEHICLES AFFECTED: | 2021 - 2024 (WD) Dodge Durango<br>This bulletin applies to vehicles equipped with Global Telematics Box Module (TBM) (Sales Code RDG). | | | MARKET APPLICABILITY:<br><div><input checked="" type="checkbox"/> NA<input type="checkbox"/> MEA<br/><input type="checkbox"/> SA<input type="checkbox"/> IAP<br/><input type="checkbox"/> EE<input type="checkbox"/> CH</div><br>NOTE: This bulletin applies to the North American markets. | |

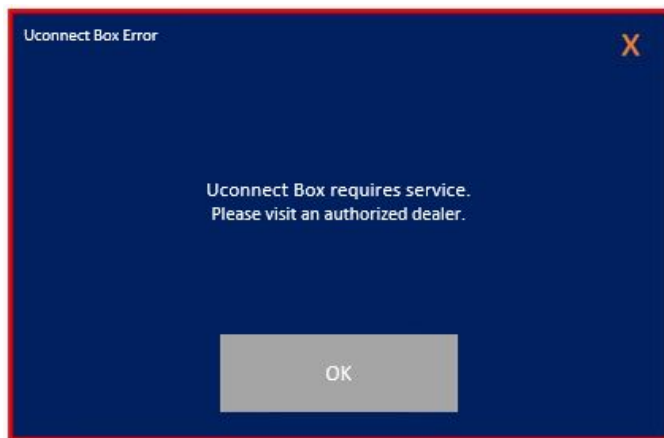
**Fig. 1**

Uconnect Box Error Message

Message display on the radio screen, "Uconnect Box requires service. Please visit an authorized dealer." [Fig. 1.](#)

**NOTE:** "Uconnect Box requires service." message can be triggered by different reasons. For an issue on a new vehicle recently switched to customer mode, please follow the New Vehicle Preparation procedure to resolve the issue. For the customer vehicle with intermittent concerns, please check the TBM, antenna and instrument panel harness connections to fix related DTC issues.

This bulletin provides information regarding the latest Firmware Over The Air (FOTA) update and provides the service technician an overview of the steps a customer will need to take to complete the update. The TBM2 software will be updated from 4.37 (SW P/N 68604567AC) or 4.38 (SW P/N 68604567AD) to 4.39 (SW P/N 68604567AE).
