Transaction No.:

**2071190/4**

HVAC failing to cool | DTC B16A1F0 in diagnostic address 00C5 | Bentayga  
Series (Hybrid)

Release date: 16 Jul 2026

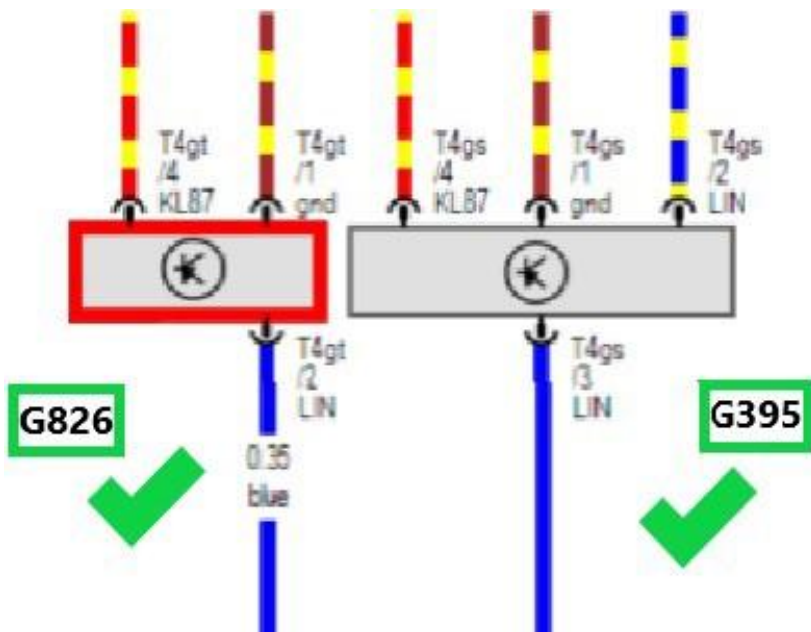
Hint: Figure 3 shows G826 and G395 as per the applicable Current Flow Diagram (Correct)
