| | ELE | 2027MY<br>Telluride Hybrid<br>(LQ2AH) |
| | 267 | July 2026 |
| SUBJECT: <b>CRANKCASE EJECTOR<br/>INSPECTION/REPLACEMENT (SA650)</b> | | |

This bulletin provides instructions to inspect and, if necessary, replace the PCV ejector on certain 2027MY Telluride Hybrid (LQ2AH) vehicles produced from December 4, 2025, through March 20, 2026. Affected vehicles may display an illuminated Malfunction Indicator Lamp (MIL) with Diagnostic Trouble Code (DTC) P04DB00 due to damage to the ejector assembly. No drivability issues are associated with this condition. Before performing the procedure, verify that the vehicle's VIN is included in the affected VIN list/range. If applicable, follow the inspection and replacement procedure outlined in this bulletin.

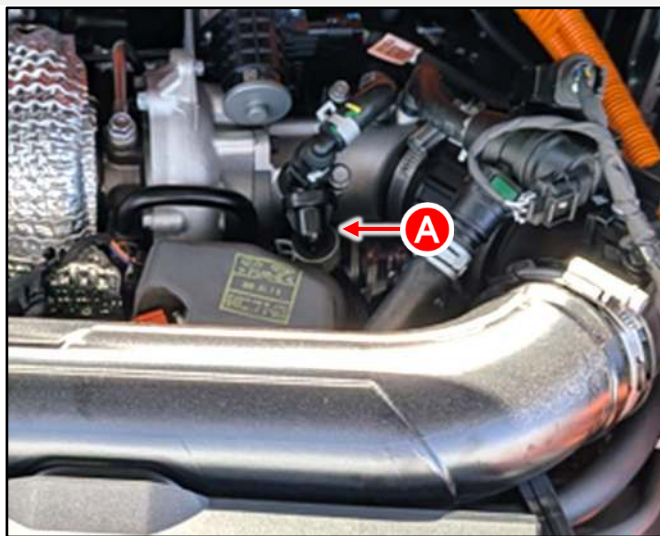
1. Open the hood and locate the crankcase ejector (A).

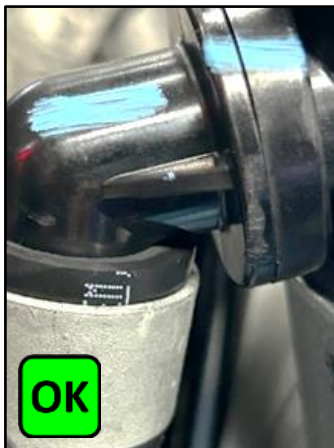
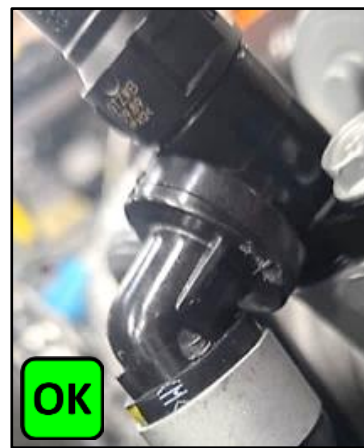
Inspect the crankcase ejector hose and crankcase ejector for any signs of cracking.

- **If the crankcase ejector is not cracked or broken (OK),** then the inspection is complete. Claim labor operation code 260A2010 only.

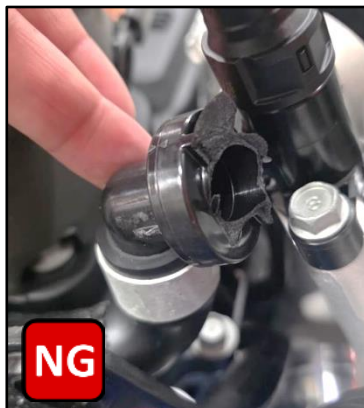
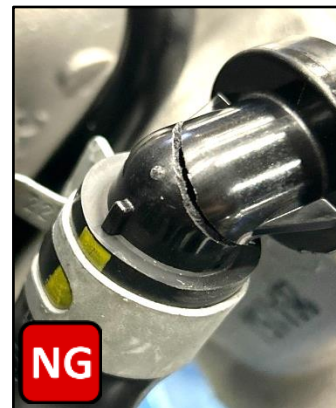
- **If the crankcase ejector is cracked or broken (NG),** then proceed to ejector assembly replacement.
