## SERVICE BULLETIN

**APPLICABILITY:** 2026MY Outback

**NUMBER:** 15-340-26

**SUBJECT:** Reprogramming Files for DTC B2A20

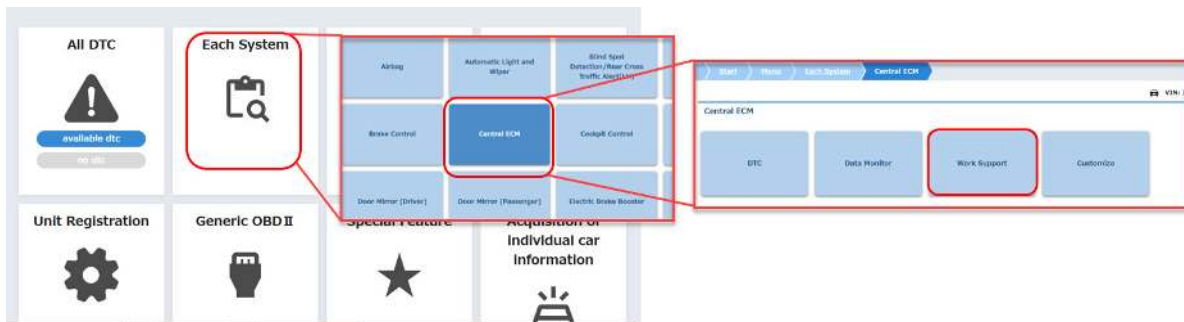
**Step 3:** Using the Subaru Select Monitor, check the Central ECM software. You can access the software information by selecting **Each System > Central ECM > Work Support**.

Is the software 4235303050 or later?

No: Perform software update.
