| <br>PARTS & SERVICES | | <b>Technical Service Bulletin (TSB)</b><br><b>Global Telematics Box (TBM) Firmware Over The Air (FOTA) Update To SW 4.39</b> | | | |
| <b>REFERENCE:</b> | <b>TSB:</b> 08-296-26<br><b>GROUP:</b> 08 - Electrical | <b>Date:</b> | July 28, 2026 | <b>REVISION:</b> | — |
| <b>VEHICLES AFFECTED:</b> | <b>2025 (WD) Dodge Durango</b><br>This bulletin applies to vehicles equipped with Global Telematics Box Module (Sales Code RDG). | | | <b>MARKET APPLICABILITY:</b><br><input checked="" type="checkbox"/> NA <input type="checkbox"/> MEA<br><input type="checkbox"/> SA <input type="checkbox"/> IAP<br><input type="checkbox"/> EE <input type="checkbox"/> CH<br><b>NOTE:</b> This bulletin applies to the North America market. | |

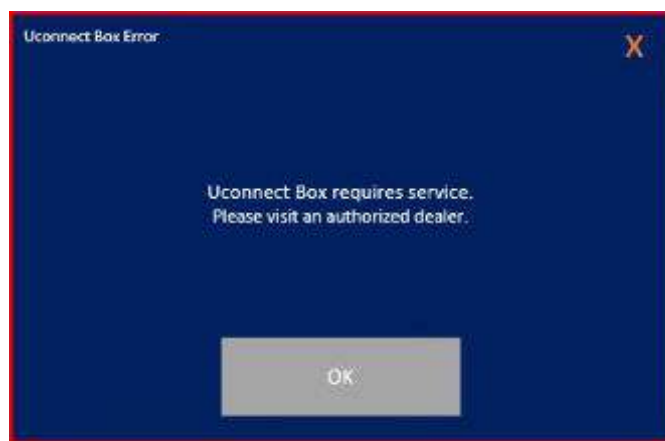
**Fig. 1**

| <b>CUSTOMER SYMPTOM:</b> | <b>Customers must experience a Malfunction Indicator Lamp (MIL) illumination and one or more of the following Diagnostic Trouble Codes (DTCs):</b> <ul style="list-style-type: none"><li>• B22A9-96 - ECU Internal Performance-Component Internal Failure.</li><li>• B1560-11 - Cellular Antenna 1-Circuit Short To Ground.</li><li>• B1560-13 - Cellular Antenna 1-Circuit Open.</li><li>• B1561-11 - Cellular Antenna 2-Circuit Short To Ground.</li><li>• B1561-13 - Cellular Antenna 2-Circuit Open.</li><li>• B1562-14 - GPS Antenna-Circuit Short To Ground Or Open.</li></ul> <b>Customers may also experience the following:</b> <ul style="list-style-type: none"><li>• "UConnect Box Requires Service" Message in Radio Display.</li></ul> | | | | |
| <b>CAUSE:</b> | <b>TBM Software</b> | | | | |

Uconnect Box Error Message

Message display on the radio screen "Uconnect Box requires service. Please visit an authorized dealer." [Fig. 1.](#)

This bulletin provides information regarding the latest Firmware Over The Air (FOTA) update and provides the service technician an overview of the steps a customer will need to take to complete the update. The TBM software will be updated from 4.37 and 4.38 to 4.39 (243187 SW PN number).

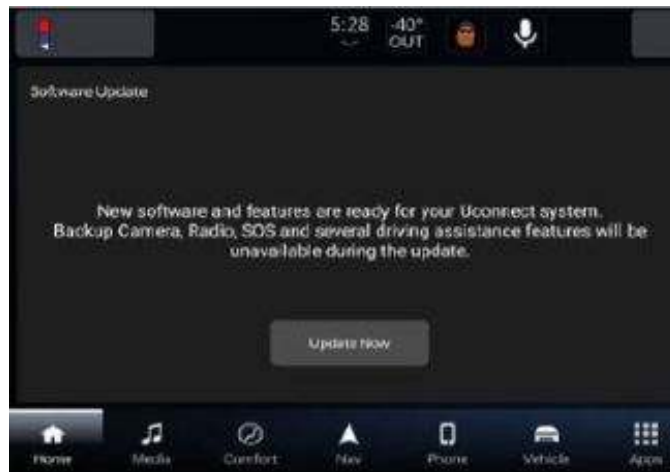
**Fig. 2**

Software Acceptance Screen

1. The vehicle needs to be in 'Park'. The ignition needs to be in the off position.
2. If the customer selects “Update Now” [Fig. 2](#), they can shut off the vehicle and leave. The update will be completed automatically.

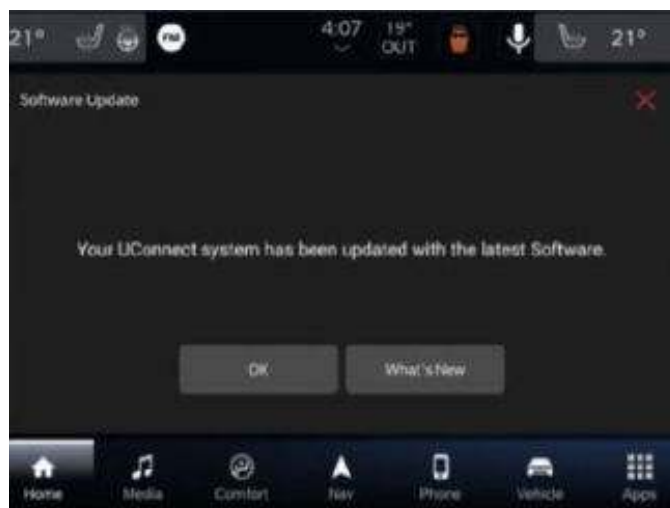
**Fig. 3**

Software Update Confirmation Screen

3. Upon completion of update, the radio will display a confirmation message [Fig. 3](#).
