## Technical product information

| <b>Topic</b> | Window Drop Glass Operation Continental GT/GTC 19-24MY |
| <b>Transaction No.</b> | 2080375/4 |

Window Drop Glass Operation | Continental GT/GTC |19-24MY

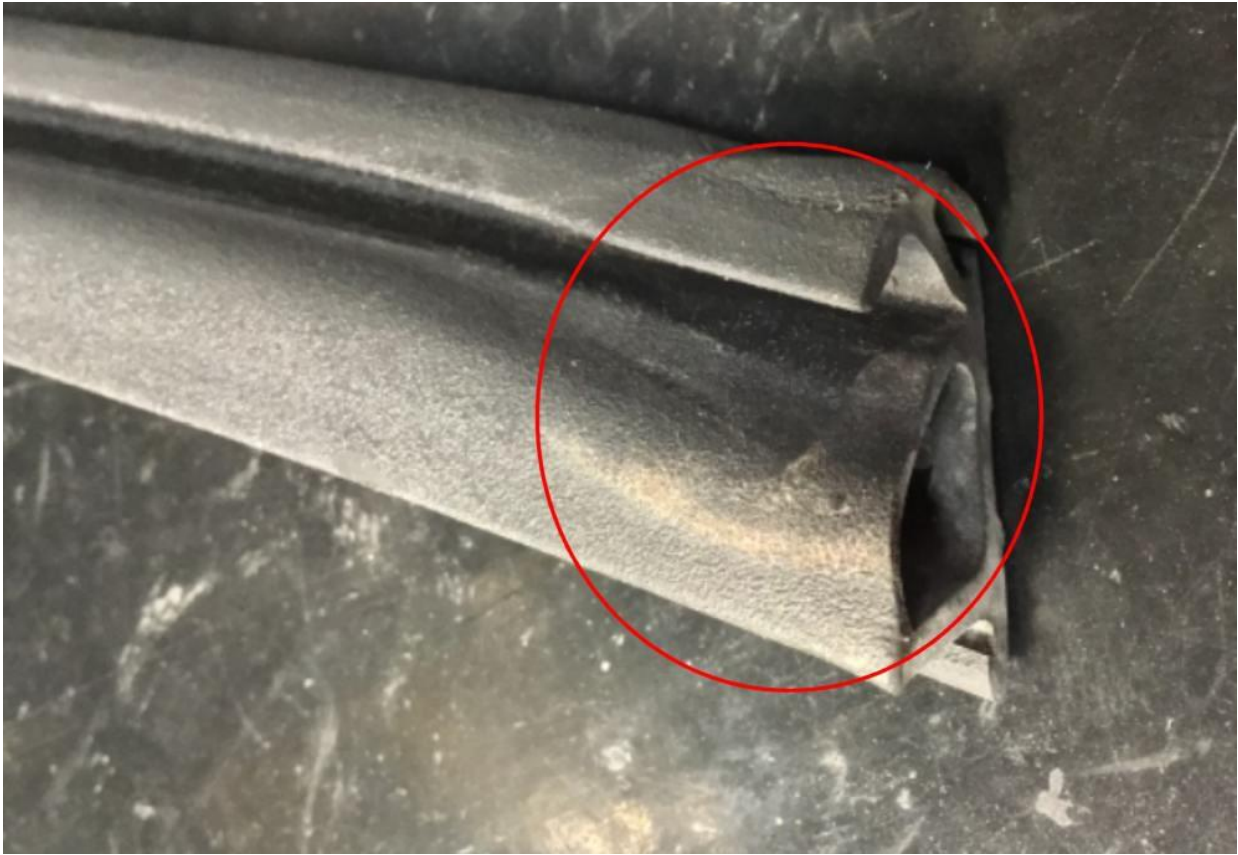
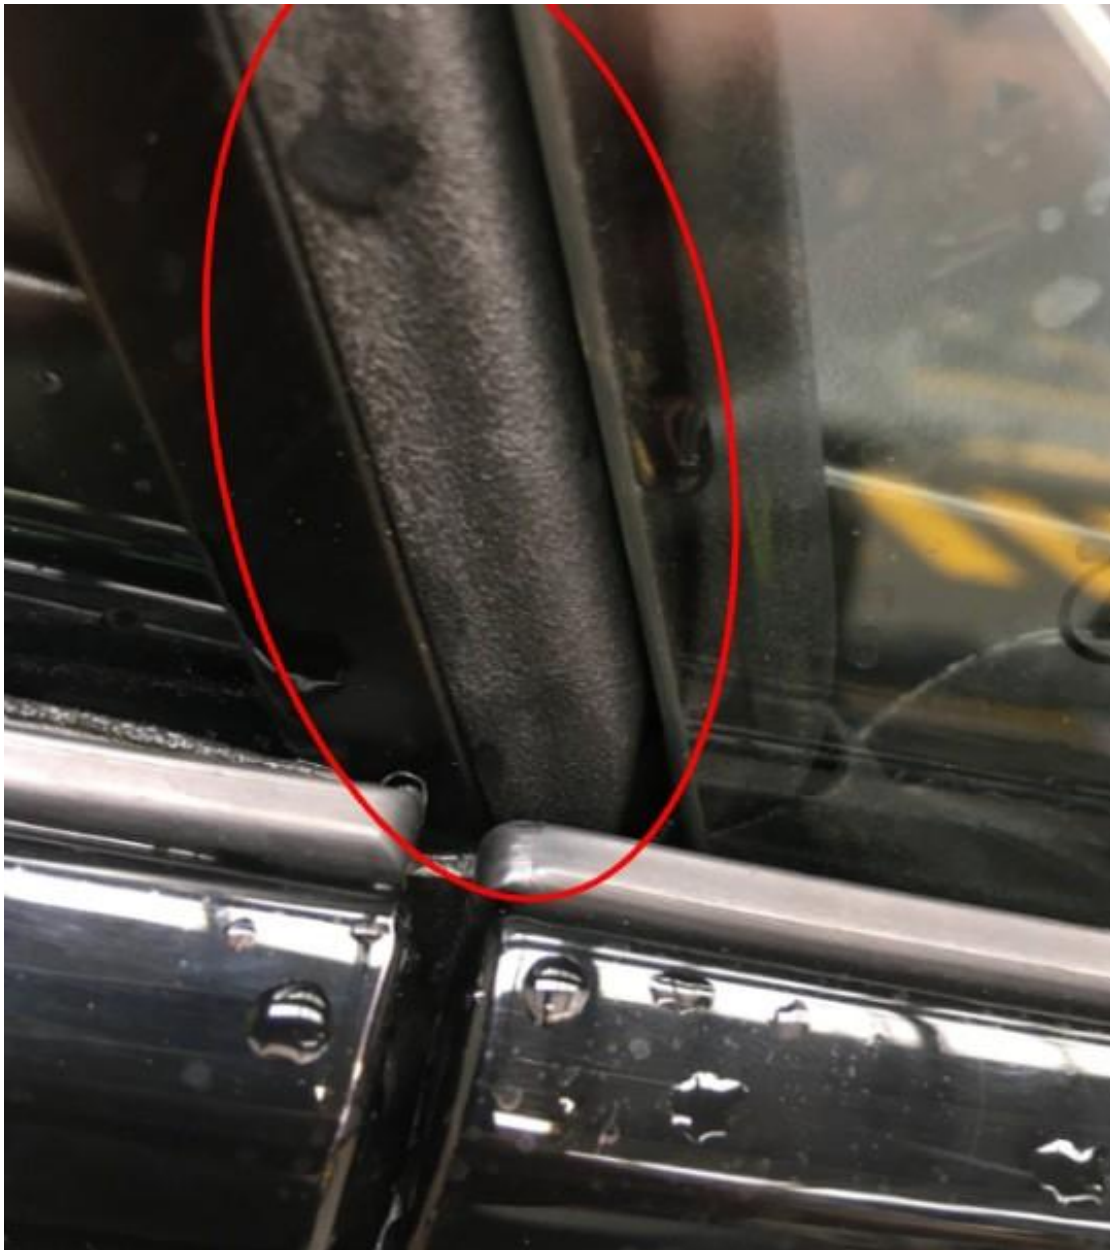
Figure 7

- Damage
- Splits
- Tears
- Misalignment
- Incorrectly fitted / located
- Drop glass seal deformation (see Figures 7 and 8 as examples)

**NOTE:** Any issues found with the window seals must be rectified before conducting the remaining steps

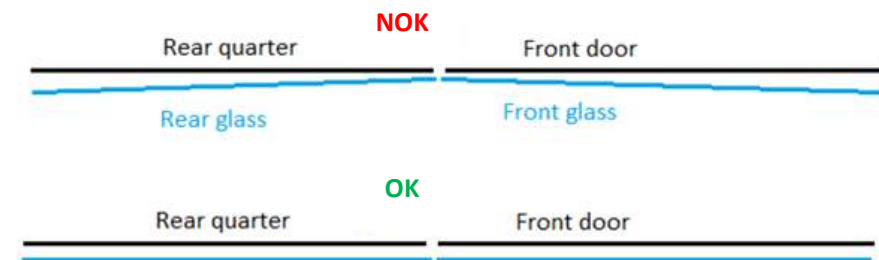
See image below, for OK and NOK after  
adjustment/checking
