**Technical Service Bulletin (TSB)**  
**AWD Drivetrain Control Module (DTCM) Reconfiguration**

| REFERENCE: | TSB: 08-307-26<br>GROUP: 08 - Electrical | Date: | August 5, 2026 | REVISION: | — |
| VEHICLES AFFECTED: | 2026 (KM) Jeep Cherokee<br>This bulletin applies to vehicles built on or after January 02, 2025 (MDH 0102XX) and built on or before July 16, 2026 (MDH 0716XX) equipped with a Jeep Active Drive I (Sales Code DK2). | | | MARKET APPLICABILITY:<br><div><input checked="" type="checkbox"/> NA<input type="checkbox"/> MEA<br/><input type="checkbox"/> SA<input type="checkbox"/> IAP<br/><input type="checkbox"/> EE<input type="checkbox"/> CH</div><br>NOTE: This bulletin applies to the North American market. | |

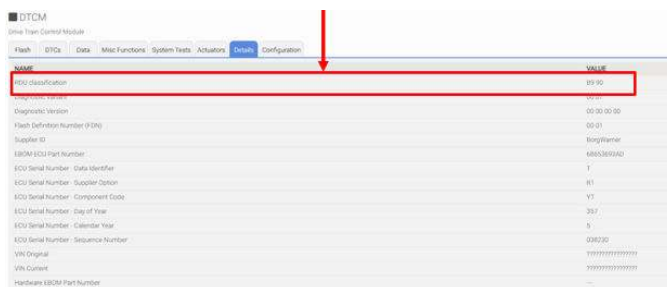
- Using wiTECH, Inspect the RDU Classification Code located under the details tab of the DTCM.

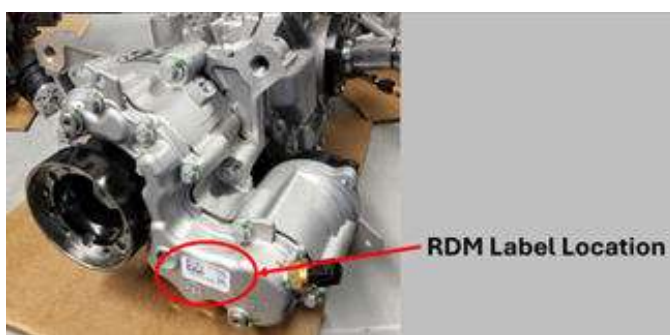
**Fig. 2**  
RDM Label Location

3. Raise the vehicle, record the Classification Code from the RDU Part Number Label.
