## Technical Service Bulletin (TSB)

### Umbrella Valve Seal Missing From Cylinder Head Cover

| REFERENCE: | TSB: 09-017-26<br>GROUP: 09 - Engine | Date: | August 5, 2026 | REVISION: | — |
| CAUSE: | Cover Cylinder Head Umbrella valve seal missing | | | | |

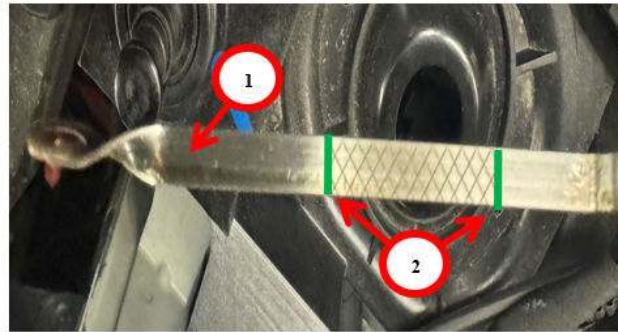
**Fig. 1**  
Oil Level Inspection

1 - Oil Level - Low  
2 - Oil Level - Acceptable Range

2. Is the oil level low [Fig. 1](#)?
  - YES>>> Proceed to [Step 3](#).
  - NO>>> This bulletin has been completed. Use Inspection LOP 09-35-20-98) to close the active RSU.  
**Refer to service library for further misfire diagnosis.**

3. If the engine oil level is found to be low, remove the Positive Crankcase Ventilation (PCV) valve. Refer to the detailed service procedures available in DealerCONNECT/Service Library under: Service Info> 25 - Emissions Control / Crankcase Ventilation / Valve, Positive Crankcase Ventilation (PCV) / Removal and Installation.

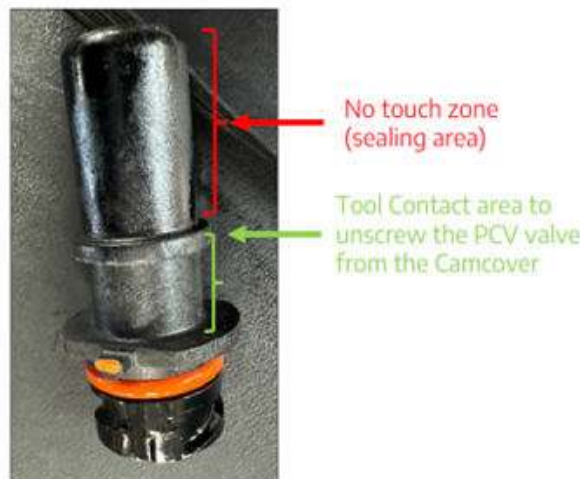
**Fig. 2**  
PCV Valve During Removal

**NOTE: Be sure to follow warnings regarding location on the PCV valve where tool contact should be avoided [Fig. 2](#).**

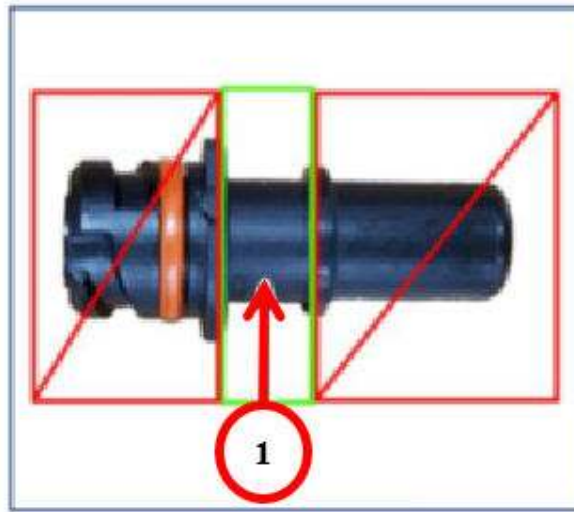
**Fig. 3**  
Approved Zone - PCV Valve Removal

**NOTE:** Use a pair of thin nosed pliers inserted into the approved zone on the PCV valve for removal [Fig. 3](#).

1 - Approved Zone In Green

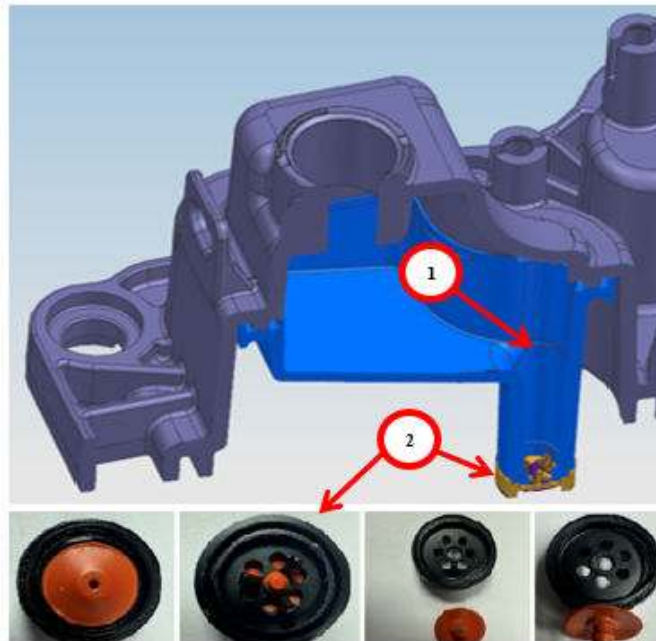
**Fig. 4**  
Borescope to PCV Valve Opening

4. With the PCV valve removed, insert a borescope into the PCV valve opening [Fig. 4](#) to inspect if the umbrella valve is missing or present [Fig. 5](#) [Fig. 6](#).

1 - PCV Valve Chamber - PCV Valve Removed  
2 - Umbrella Valve Seal
