# Service Bulletin

Bulletin No.: PIP6130

**Subject:** Diagnostic Tips LK0 P0299

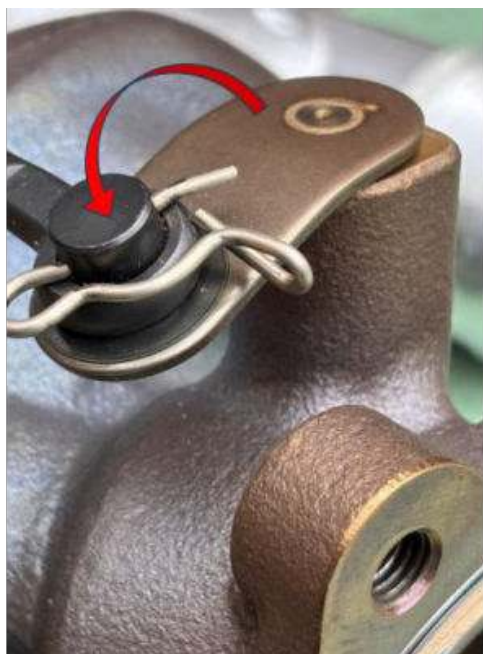
7200176

| <b>Cause</b> | The cause of this condition may be a misaligned turbocharger compressor housing relative to the rest of the turbocharger assembly, or a bent wastegate lever. |

Verify the turbocharger wastegate lever is not bent. See picture below showing a bent wastegate lever.

If the turbocharger wastegate lever is bent, replace the turbocharger.
