## Technical Service Bulletin (TSB)

### Umbrella Valve Seal Missing From Cylinder Head Cover

| REFERENCE: | TSB: 09-017-26 REV. A<br>GROUP: 09 - Engine | Date: | August 19, 2026 | REVISION: | 09-017-26 |
| VEHICLES AFFECTED: | 2026 - 2027 (WL) Jeep Grand Cherokee / Grand Cherokee L<br>This bulletin applies to vehicles built on or before August 15, 2026 (MDH 0815XX) equipped with a 2.0L Hurricane 4 Turbo W/ESS (Sales Code EC7). | | | MARKET APPLICABILITY:<br><div><input checked="" type="checkbox"/> NA<input type="checkbox"/> MEA<br/><input type="checkbox"/> EE<input type="checkbox"/> IAP<br/><input type="checkbox"/> SA<input type="checkbox"/> CH</div><br>NOTE: This bulletin applies to North America markets. | |

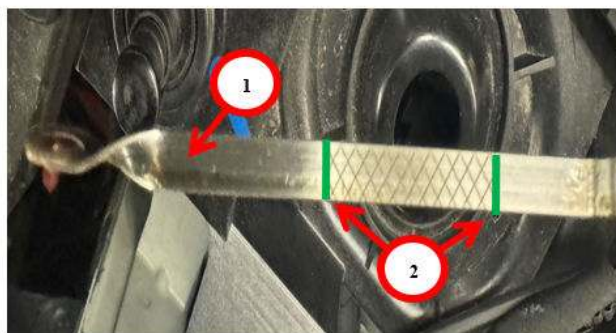
**Fig. 1**  
Oil Level Inspection

1 - Oil Level - Low  
2 - Oil Level - Acceptable Range

2. Is the oil level low [Fig. 1](#)?
  - YES>>> Proceed to [Step 3](#).
  - NO>>> This bulletin has been completed. Use Inspection LOP 09-35-20-98) to close the active RSU.  
**Refer to service library for further misfire diagnosis.**

3. If the engine oil level is found to be low, remove the Positive Crankcase Ventilation (PCV) valve. Refer to the detailed service procedures available in DealerCONNECT/Service Library under: Service Info> 25 - Emissions Control / Crankcase Ventilation / Valve, Positive Crankcase Ventilation (PCV) / Removal and Installation.

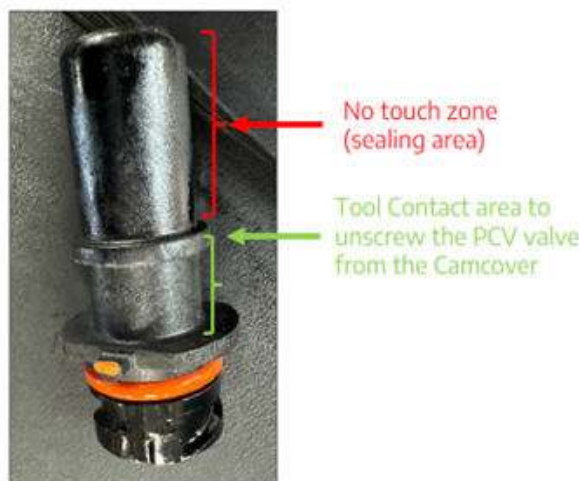
**Fig. 2**  
PCV Valve During Removal

**NOTE: Be sure to follow warnings regarding location on the PCV valve where tool contact should be avoided [Fig. 2](#).**

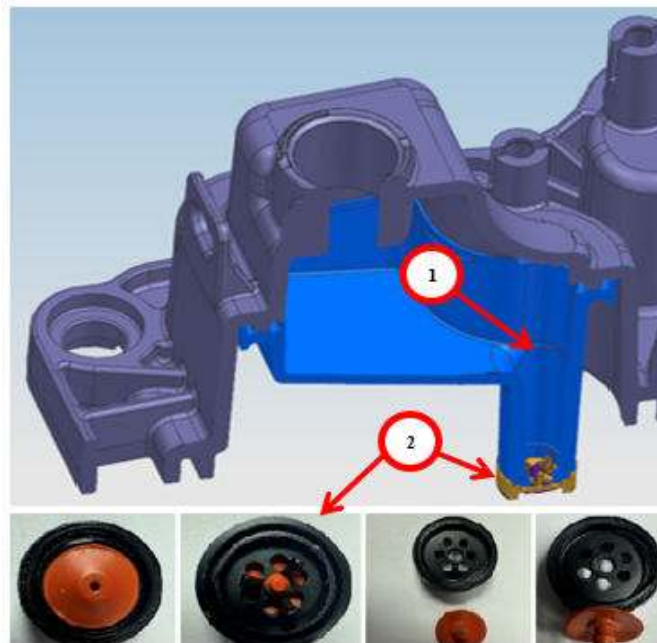
**Fig. 4**  
Borescope to PCV Valve Opening

4. With the PCV valve removed, insert a borescope into the PCV valve opening [Fig. 4](#) to inspect if the umbrella valve is missing or present [Fig. 5](#) [Fig. 6](#).

1 - PCV Valve Chamber - PCV Valve Removed  
2 - Umbrella Valve Seal

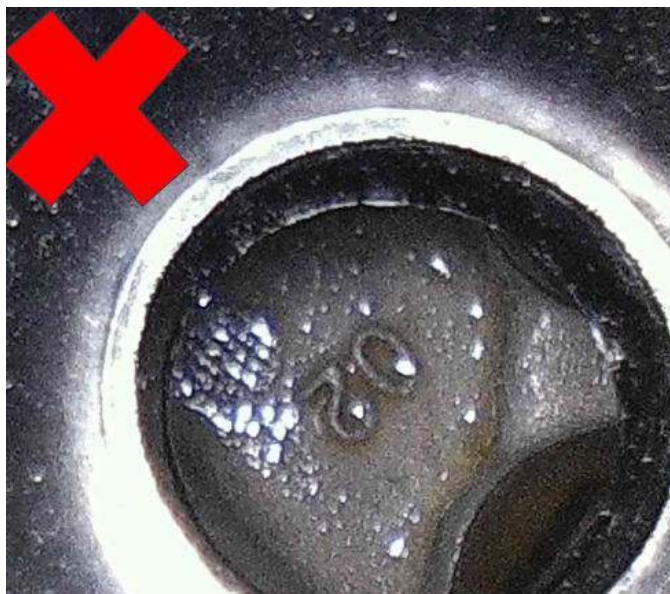
**Fig. 5**  
Umbrella Valve Seal - Missing

| CAUSE: | Cover Cylinder Head Umbrella valve seal missing | | | | |

5. Is the umbrella valve seal missing [Fig. 5](#)?
  - YES>>> Replace the cylinder head cover assembly. Refer to the detailed service procedures available in DealerCONNECT/Service Library under: Service Info> 09 - Engine, 2.0L / Cylinder Head / Cover(s), Cylinder Head / Removal and Installation and then proceed to [Step 6](#).
  - NO>>> This bulletin has been completed. Use Inspection LOP (09-35-20-98) to close the active RSU.  
**Perform further oil consumption diagnosis as required.**
6. Ensure that the engine oil level is to proper specification.
7. \*\*Using wiTECH, perform the PCM Reset ECU routine. Navigate to **Guided Diagnostics > Reset ECU**, select **PCM**, and follow the on-screen instructions to complete the procedure.\*\*
8. Clear DTCs.
