## Technical Service Bulletin (TSB)

### Umbrella Valve Seal Missing From Cylinder Head Cover - UNSOLD POPULATION ONLY

| REFERENCE: | TSB: 09-020-26<br>GROUP: 09 - Engine | Date: | August 20, 2026 | REVISION: | — |
| VEHICLES AFFECTED: | 2026 - 2027 (WL) Jeep Grand Cherokee / Grand Cherokee L<br>This bulletin applies to vehicles built on or before August 31, 2026 (MDH 0831XX) equipped with a 2.0L Hurricane 4 Turbo W/ESS (Sales Code EC7). | | | MARKET APPLICABILITY:<br><div><input checked="" type="checkbox"/> NA<input checked="" type="checkbox"/> MEA</div> <div><input checked="" type="checkbox"/> EE<input checked="" type="checkbox"/> IAP</div> <div><input checked="" type="checkbox"/> SA<input type="checkbox"/> CH</div><br><b>NOTE:</b> This bulletin applies to North and South America, Enlarged Europe, Middle East & Africa, and India & Asia Pacific markets. | |

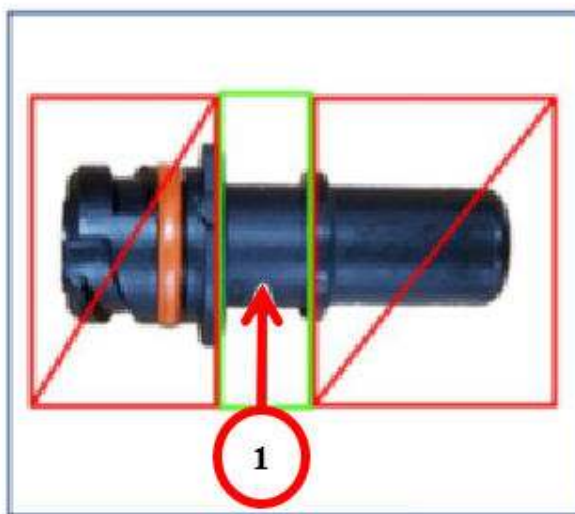
**Fig. 2**  
Approved Zone - PCV Valve Removal

**NOTE:** Use a pair of thin nosed pliers inserted into the approved zone on the PCV valve for removal [Fig. 2](#).

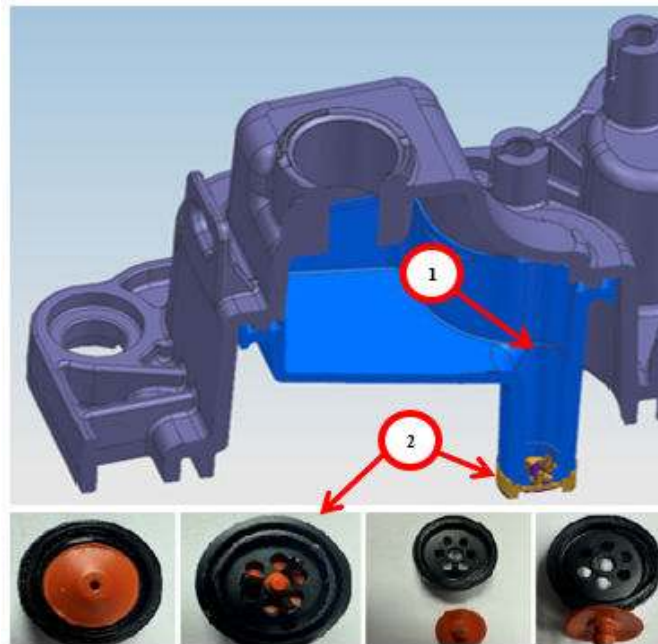
**Fig. 3**  
Borescope to PCV Valve Opening

2. With the PCV valve removed, insert a borescope into the PCV valve opening [Fig. 3](#) to inspect if the umbrella valve is missing or present [Fig. 4](#) [Fig. 5](#).

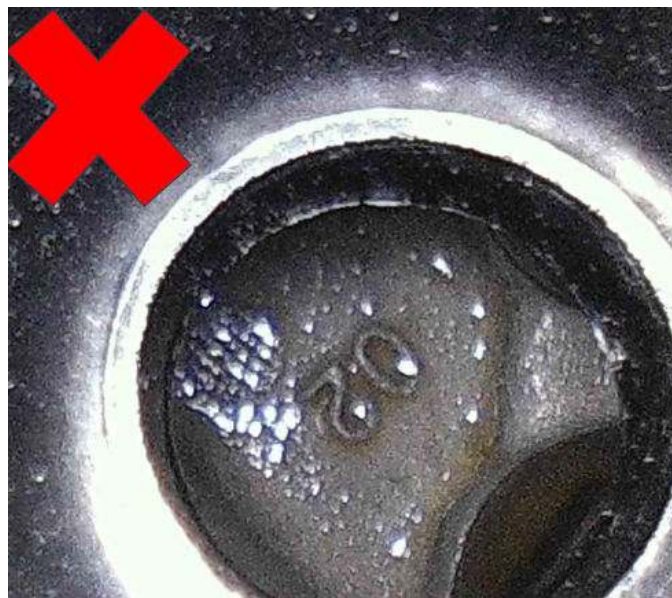
| CAUSE: | Cover Cylinder Head Umbrella valve seal missing | | | | |

1 - PCV Valve Chamber - PCV Valve Removed  
2 - Umbrella Valve Seal

**Fig. 4**  
Umbrella Valve Seal - Missing

3. Is the umbrella valve seal missing [Fig. 4](#)?
  - YES>>> Replace the cylinder head cover assembly. Refer to the detailed service procedures available in DealerCONNECT/Service Library under: Service Info> 09 - Engine, 2.0L / Cylinder Head / Cover(s), Cylinder Head / Removal and Installation and then proceed to [Step 4](#).
  - NO>>> This bulletin has been completed. Use Inspection LOP (09-35-20-98) to close the active RSU.
4. Ensure that the engine oil level is to proper specification.
5. Using wiTECH, perform the PCM Reset ECU routine. Navigate to **Guided Diagnostics > Reset ECU**, select **PCM**, and follow the on-screen instructions to complete the procedure.
6. Clear DTCs.

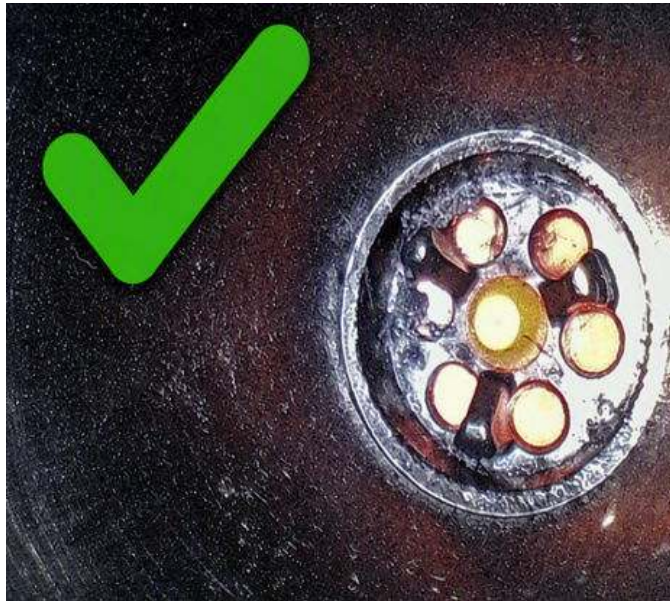
**Fig. 5**  
Umbrella Valve Seal - Present
