# Service Bulletin

Bulletin No.: PIC6662

**Subject:** CEL MIL / No Crank / Intermittent Crank / DTC P06E9

| Brand: | Model: | Model Year: | | VIN: | | Engine: | Transmission: |
|---|---|---|---|---|---|---|---|
| Chevrolet | Corvette Z06 | 2023 - 2027 | | All | All | LT6 | M1M |

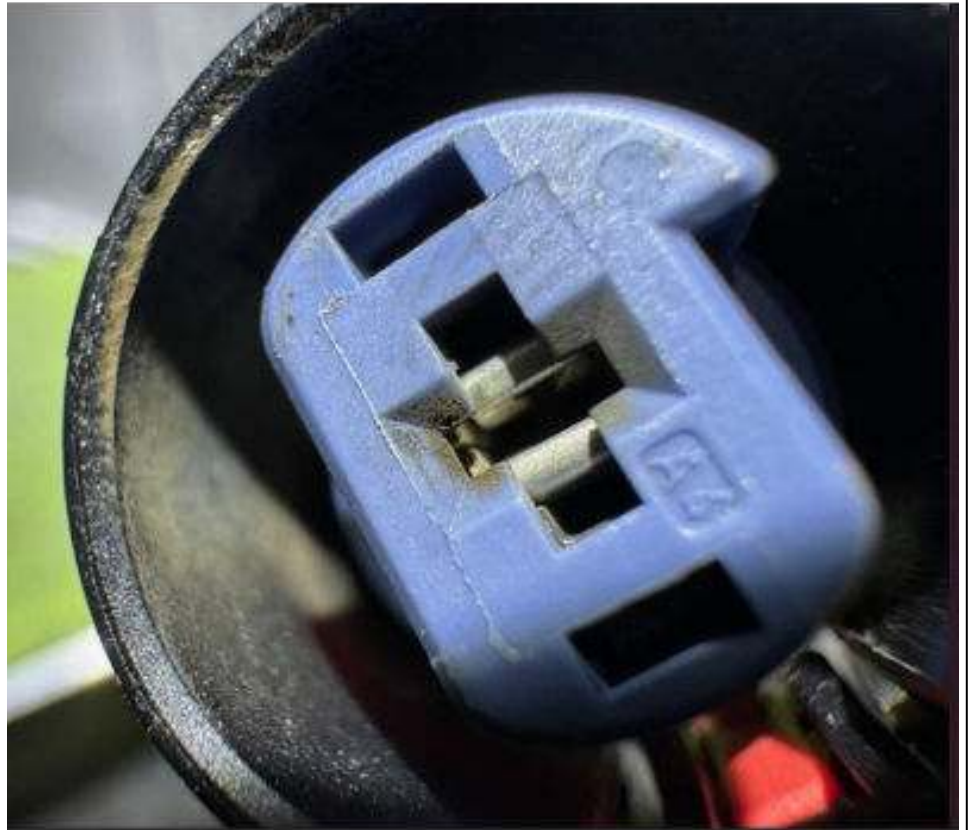
7196583

| <b>Cause</b> | <p>This concern may be caused by one of two issues related to the vehicle's starter motor.</p> <p>1) There may be a poor connection at the starter motor X2-1, which is the solenoid terminal. This is the single pin connector at the starter motor. In some cases, the terminal and/or plastic connector may show signs of overheating as seen in the photo below. This creates excessive resistance in the circuit, and as a result, the solenoid may not be powered up. As this is easy to overlook, technicians should check both the terminal tension and the plastic body of this connector for any issues.</p> |

This could happen after a long session on the track. The next step is to determine if the concern is electrical or physical in nature. First inspect the solenoid connector / terminal by removing the intake manifold and accessing the starter motor. If an issue is found, replace it with a new pigtail as seen below.

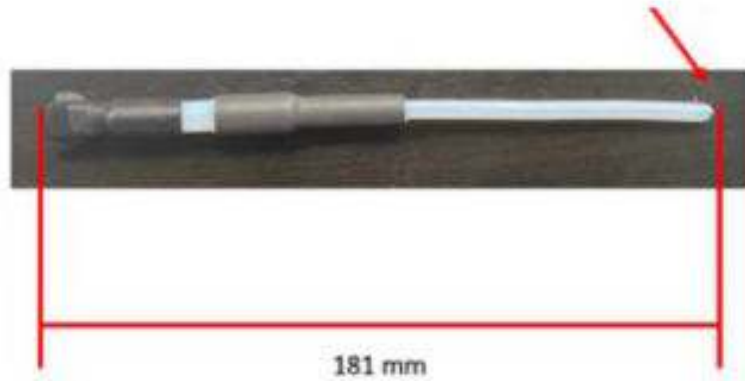
7196585

2) Because the starter motor on these engines is located inside the intake manifold, the starter motor housing is equipped with an actual drain hose. It runs from the starter motor out through a small bore cast into the engine block. Depending on when the vehicle was manufactured, or if the starter was previously replaced in the vehicle's history, the starter motor may have one of two different style drain hoses on it. The older style is white / opaque and it is straight, as seen in the photo below.

If no electrical concerns are noted, continue with inspection of the water management system of the starter motor. Make sure that water is able to properly flow through the drain tube on the starter motor and repair as needed.

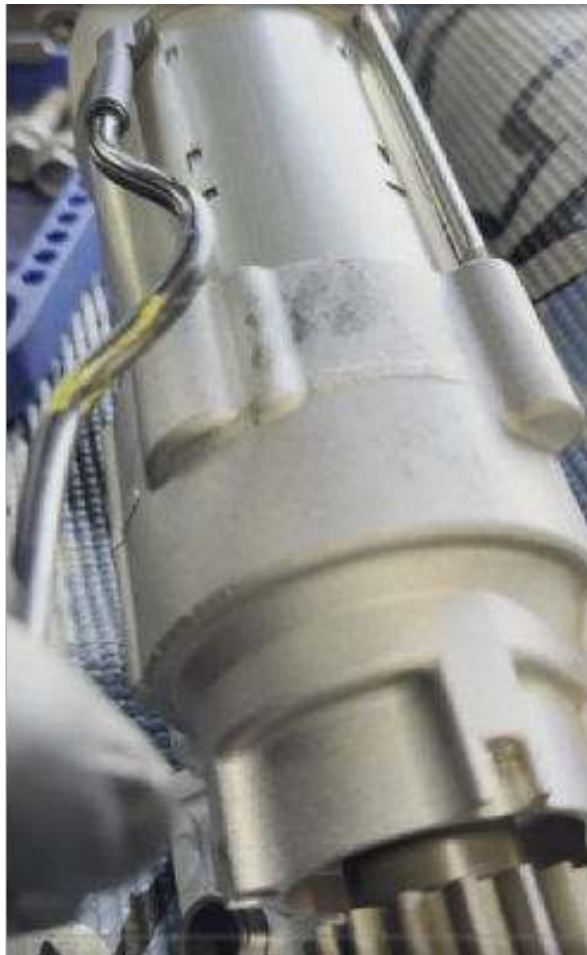
7196584

The newer style is black and S-curved. Regardless of which style the vehicle is equipped with, technicians should inspect the drain tube for a pinched or restricted hose, or for any other obvious issues with the water management system of the starter motor.

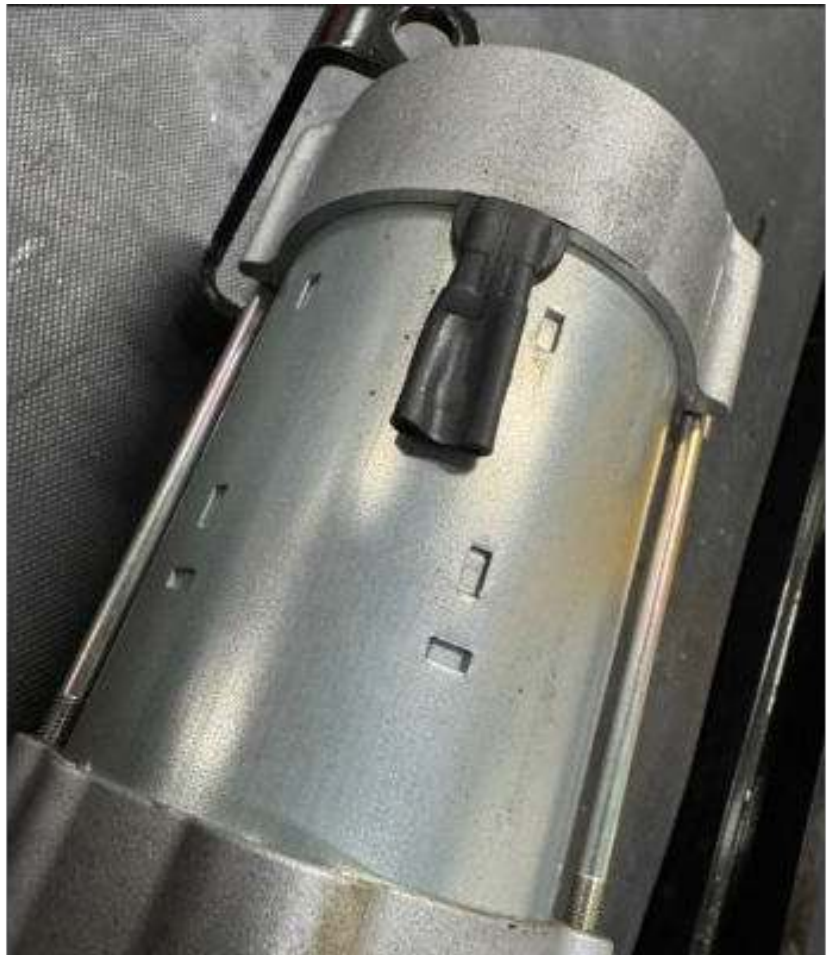
7196581

This photo shows a drain hose that has separated from the starter motor housing.

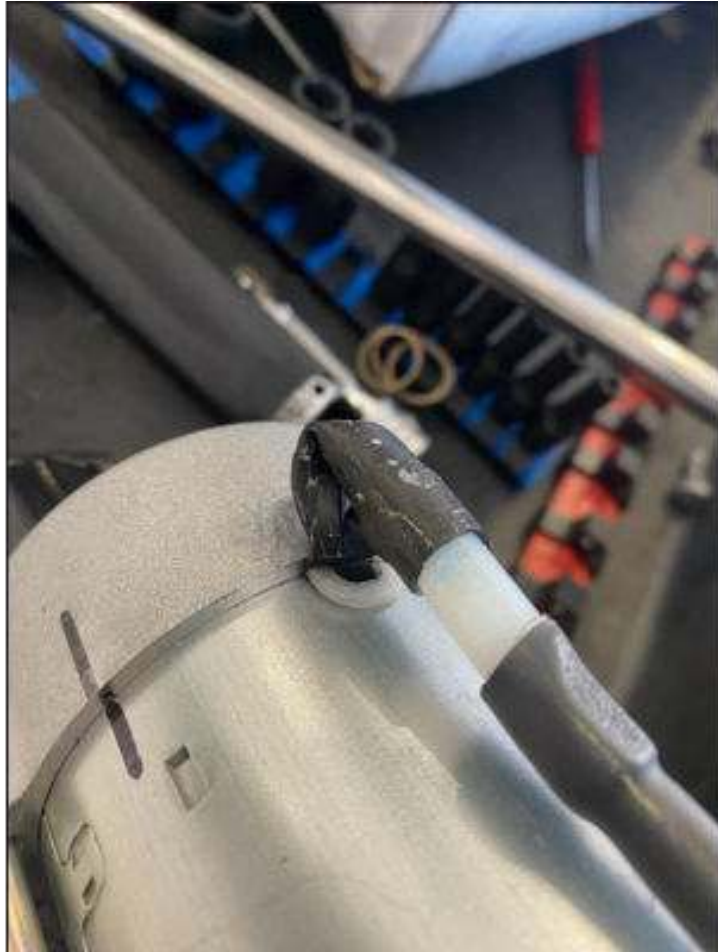
7196582

This photo shows an example of a kinked drain hose right at the starter motor housing.
