## Technical Service Bulletin (TSB)

### Headlamp And Dash Wiring Not Secure

| <b>REFERENCE:</b> | <b>TSB:</b> 08-314-26<br><b>GROUP:</b> 08 - Electrical | <b>Date:</b> | August 26, 2026 | <b>REVISION:</b> | – |
| <b>VEHICLES AFFECTED:</b> | 2025 - 2026 (MP) Jeep Compass | | | <b>MARKET APPLICABILITY:</b><br><input checked="" type="checkbox"/> NA <input type="checkbox"/> IAP<br><input type="checkbox"/> EE <input type="checkbox"/> MEA<br><input type="checkbox"/> SA <input type="checkbox"/> CH<br><b>NOTE:</b> This bulletin applies to the North American market. | |

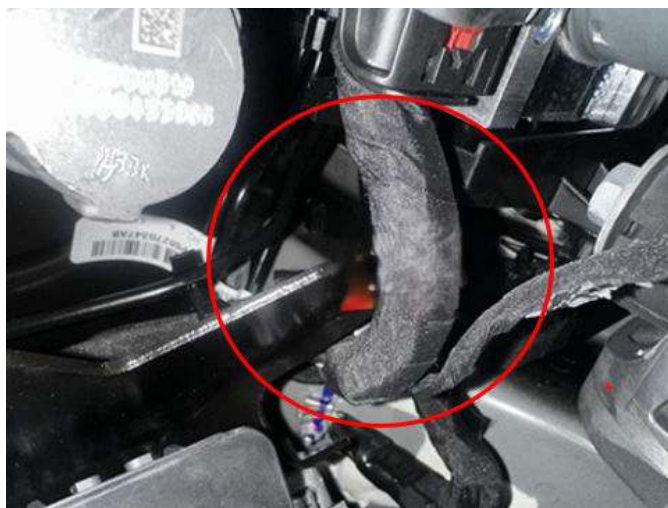
| <b>CAUSE:</b> | Harness retainer failure | | | | |

**Fig. 1**  
Incorrectly Routed Harness

1. Open the hood.
2. Inspect the Anti-lock Braking System (ABS) module harness routing [Fig. 1](#).
3. Is the ABS module harness routed forward of the Transmission control module (TCM) mounting bracket **OR is the ABS module harness clip not attached to the brake line?**
  - YES>>> Proceed to [Step 4](#).
  - NO>>> This bulletin does not apply. Use Inspect LOP (08-91-PN-91) to close this active RSU.
4. Remove the battery tray. Refer to the detailed service procedures listed in DealerConnect>ServiceLibrary under:08 - Electrical / 8F - Engine Systems / Battery System / Tray, Battery / Removal.
5. Disconnect the ABS module harness connector and route the harness **rearward** of the TCM bracket then reconnect the harness [Fig. 2](#).

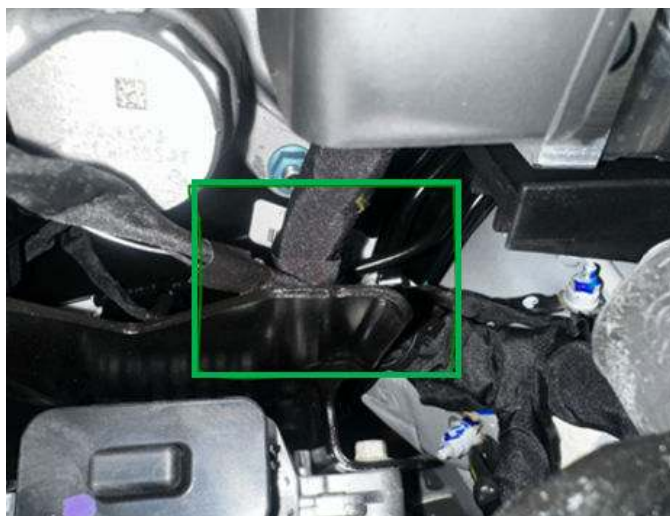
**Fig. 2**  
Correctly Routed Harness

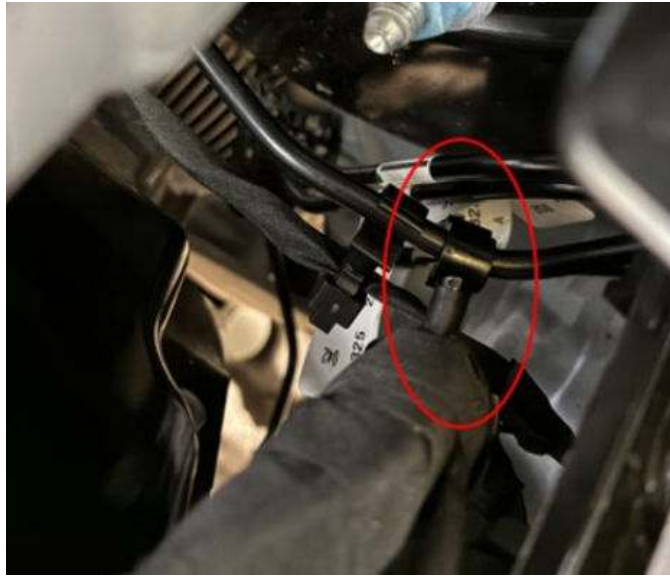
**Fig. 3**

6. Identify the C-clip retainer attached to the brake lines [Fig. 3](#).

C-Clip At Brake Line

7. Add the strap tie from the harness to the brake line at the C-clip retainer area to better secure the harness.
