# Service Alert

"TCU MALFUNCTION. HAVE THE VEHICLE INSPECTED."  
MESSAGE AND DTC B1252:87 OR U0198:00 STORED

Service Alert No.: SA-012/26

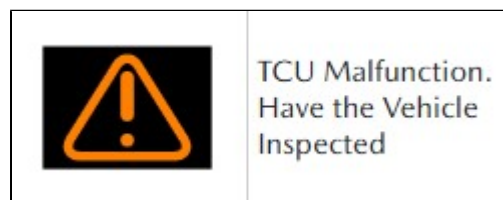
Some customers may experience a message "TCU Malfunction. Have the Vehicle Inspected" in the instrument cluster.
