## Various White Messages Regarding Driver Assistance Systems/Fault Memory Entry "C12D5FA" in the ZFAS Control Unit (75/25)

Model Line: **911 (992)**

Model Year: **from 2020**

Concerns: **Control unit for driver assistance systems (ZFAS)**

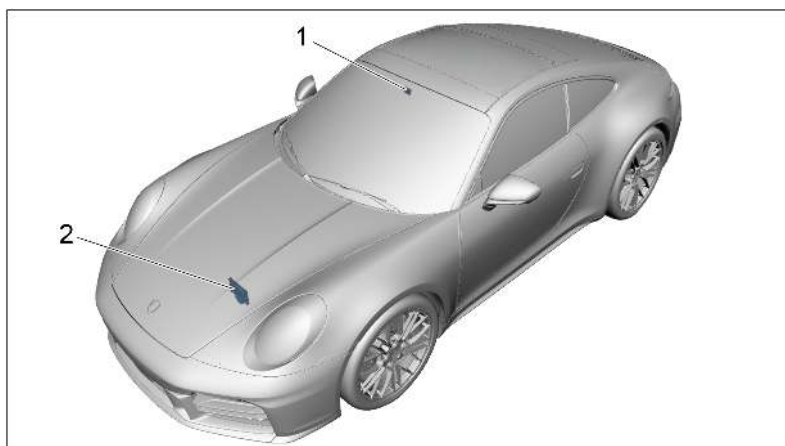
Installation Position:

- 1 Front camera for driver assistance systems
- 2 Control unit for driver assistance systems (ZFAS)

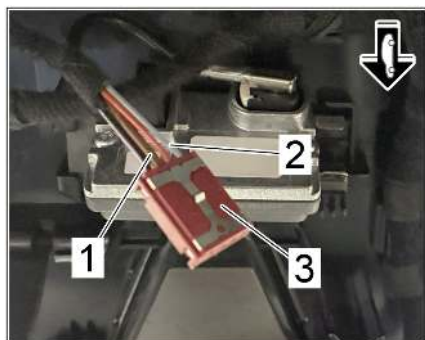
Bypassing ground loop

Reason: If the fault memory entry is **passive**, there is a possibility that electromagnetic incompatibility/influences on the video line may lead to the above-mentioned complaints.

- 4.1** Unpin electric line (**brown**) -1- from **chamber 2** of the connector housing -3-.
  - 4.2** Unpin electric line (**grey**) -2- from **chamber 4** of the connector housing -3-.

- 4.3** Disconnect plug contacts on the electric lines (brown and grey) -1 and 2-.
  - 4.4** Crimp electric lines (brown and grey) -1 and 2- with each other.  
Work procedure, see: **9797INA1 Information on electric crimp/splice connections**
