## Technical product information

**2078265/3**

All wheel drive, air suspension and differential warning on DIP DTC U013200 is present in 0019

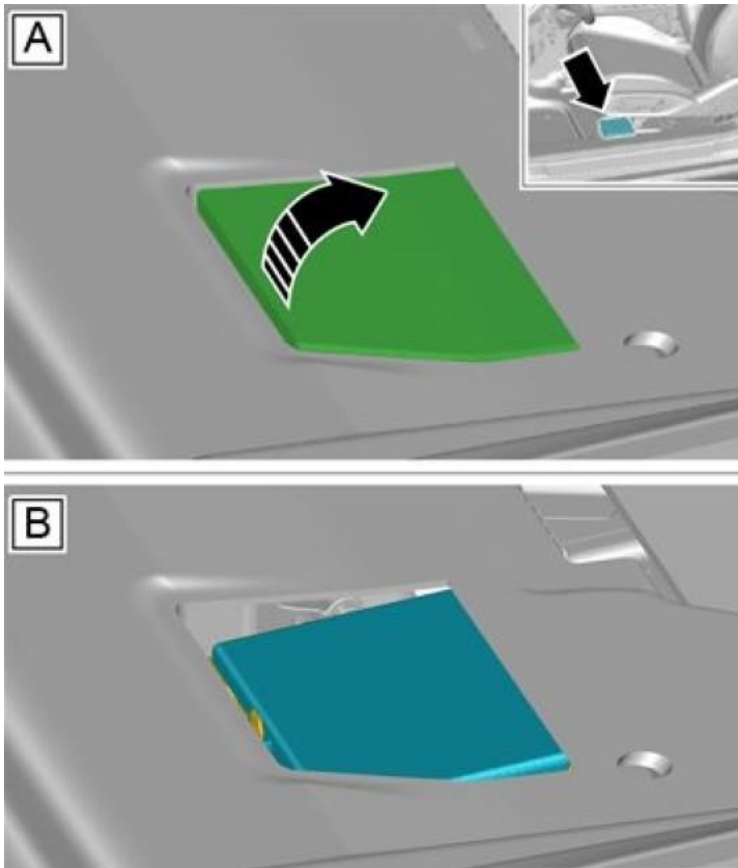
**Figure 1.** Fuseboard lid removal

2. Remove the fuse board lid -B- .

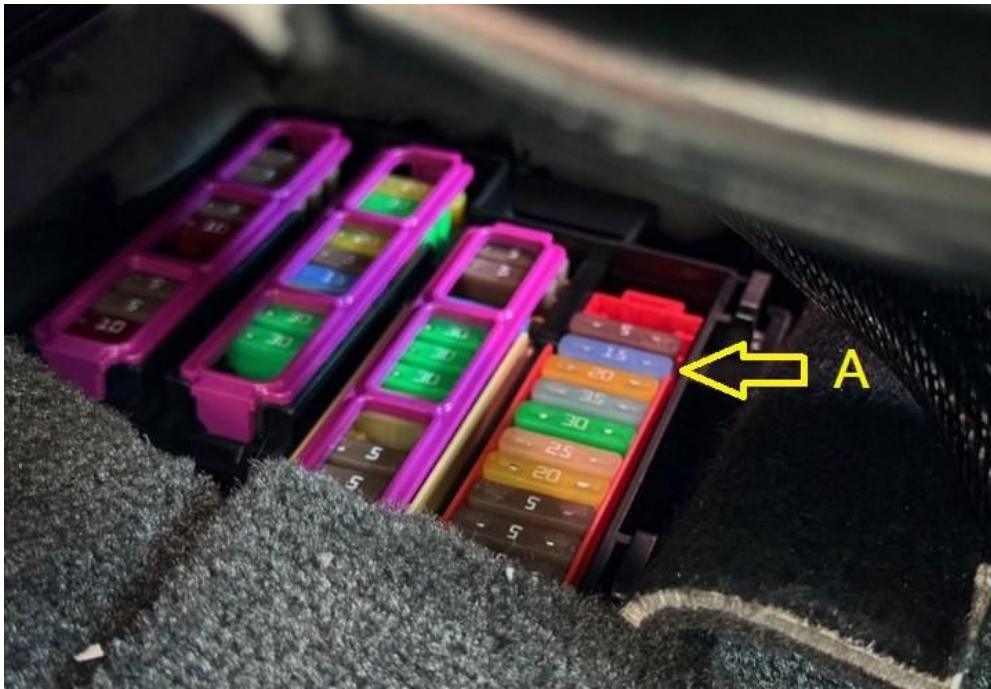
- Fuse carrier 2 (ST4 RED – LHS Font Seat, floor) (Figure 2, A)

**Figure 2.** Fuse control panel

3. Perform a reset of the suspension control module supply fuse (address word 0074) by removing the KL30 15A fuse - location 4 located on the red fuse holder N (rearmost of all 4) for 10 seconds.

**Tip:** You must consult the applicable wire diagram for the vehicle you are working on if there is no fuse in position F4, or the fuse in position F4 is not 15A.
