## Technical Service Bulletin (TSB)

### Flash: Vehicle System Interface Module (VSIM) Updates

| REFERENCE: | TSB: 08-331-26<br>GROUP: 08 - Electrical | Date: | September 11, 2026 | REVISION: | — |
| VEHICLES AFFECTED: | 2025 - 2026 (DJ) RAM 2500 Pickup<br>2025 - 2026 (DD) RAM 3500 Cab Chassis<br>2025 - 2026 (DP) RAM 4500/5500<br>2025 - 2026 (D2) RAM 3500 Pickup<br>This bulletin applies to vehicles built on or before January 10, 2026 (MDH 0110XX) equipped with Upfitter Electronic Module (VSIM) (Sales Code XXS). | | | MARKET APPLICABILITY:<br><div><input checked="" type="checkbox"/> NA<input checked="" type="checkbox"/> MEA</div> <div><input type="checkbox"/> SA<input type="checkbox"/> IAP</div> <div><input checked="" type="checkbox"/> EE<input type="checkbox"/> CH</div><br>NOTE: This bulletin applies to the North America, Enlarged Europe and Middle East & African markets. | |

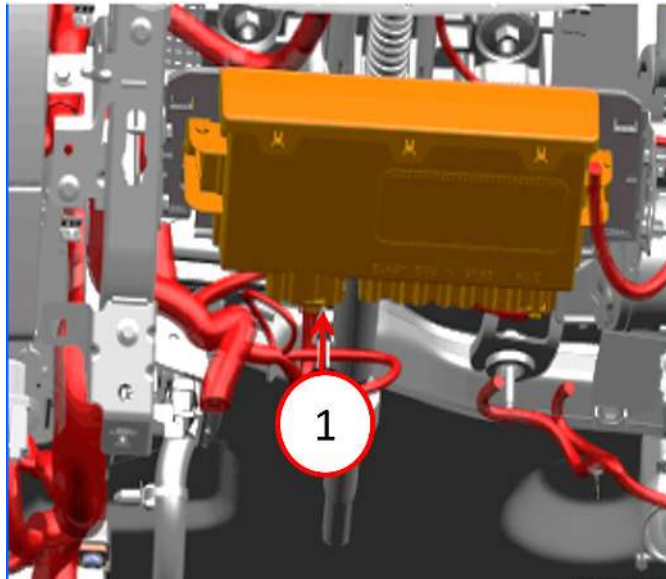
**Fig. 1**  
VSIM

1 - VSIM Connector To Disconnect

1. Is the VSIM communicating on BUS?
  - YES >>> Proceed to [Step 6](#).
  - NO >>> Proceed to [Step 2](#).
2. Disconnect and isolate the negative battery cable(s). Refer to the detailed service procedures available in DealerConnect> Service Library under: Service Info> 08 - Electrical / 8F - Engine Systems / Battery System / Battery / Removal.
3. Disconnect the VSIM connector [Fig 1](#) for 60 seconds and reconnect.
