# Technical Service Bulletin

**20 MIL on or difficulty refueling, DTC P045100, P044100, P202500, and/or P045300 stored in the ECM**

20 19 23 2050276/3 November 15, 2019. Supersedes Technical Service Bulletin Group 20 number 18-99 dated February 20, 2018 for reasons listed below.

| Model(s) | Year | VIN Range | Vehicle-Specific Equipment |
|---|---|---|---|
| A6, A7 | 2016 - 2018 | All | 3.0T |

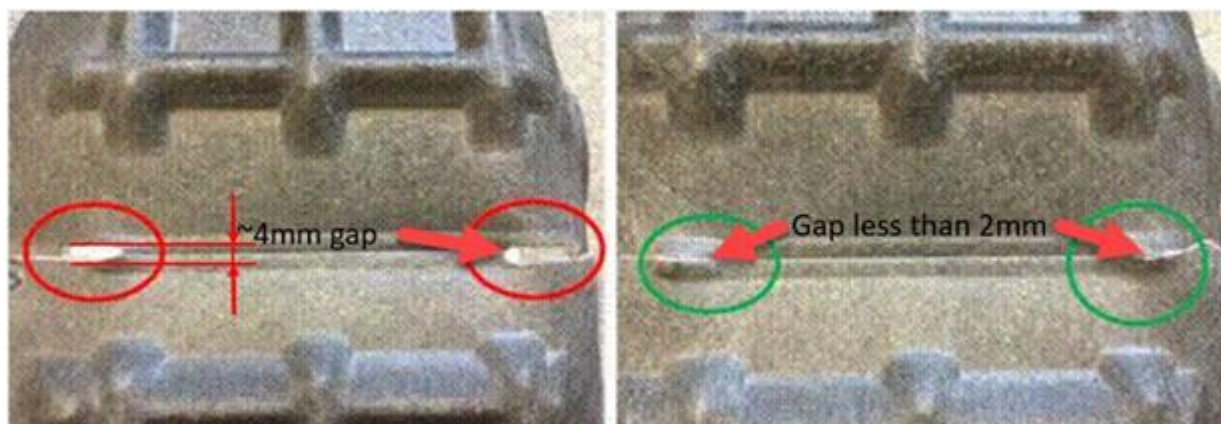
**Figure 1.** How to determine which steps to take Version 1 (~4mm gap) or Version 2 (gap less than 2mm).

### Version 1 (A6 only):

1. If the updated wheel liner has not yet been installed. Then install the updated wheel liner, which has closed slots around the NVLD filter.
  - Remove the EVAP canister, ventilation tube, and NVLD pressure switch.
  - Remove all components mounted on the EVAP canister.

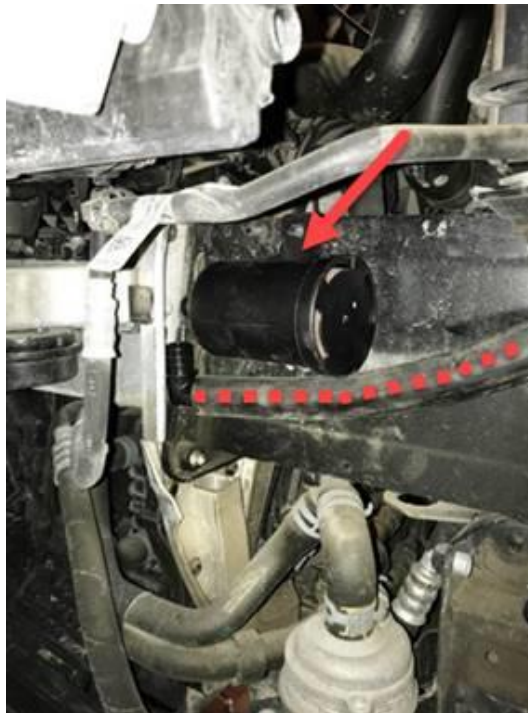
**Figure 3.** Installing the new NLVD filter.

1. Replace the EVAP canister only if weight is greater than 2650 grams.
  - Install a new J909.
  - Install the NVLD filter (new part number, Version 2) in the engine compartment on the left frame rail just in front of the ABS module, secure with M6 nut. (Figure 3).

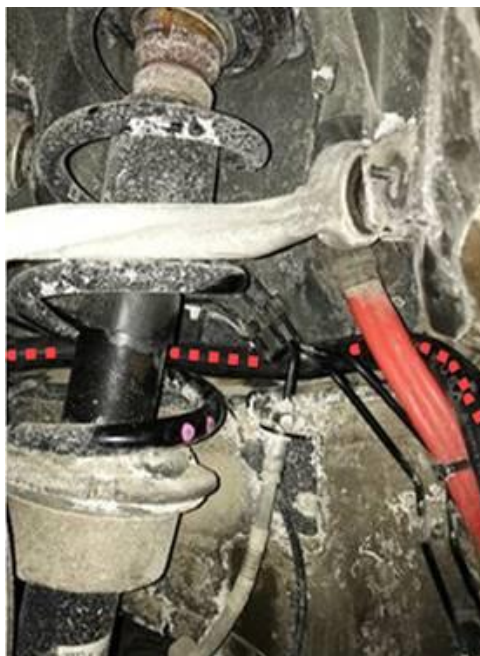
**Figure 6.** Routing the rubber hose.

Route the 5/8" ID rubber hose behind the strut and brake lines from new filter position to the J909, along the orange battery cable (Figure 5 and 6). Then secure with zip ties.

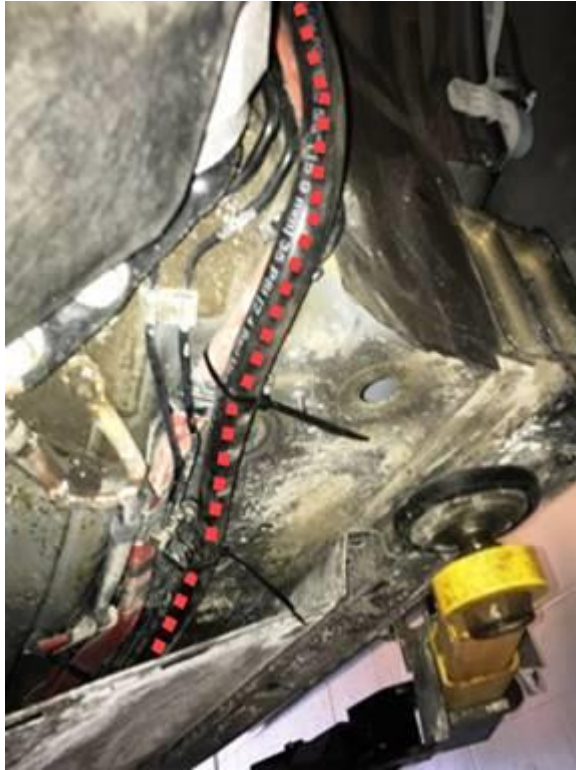
**Figure 7.** Where to zip tie the rubber hose to the battery cable.

- Routing details to the J909, along the
4. orange battery cable. Add zip-ties every 12 inches (Figure 7).

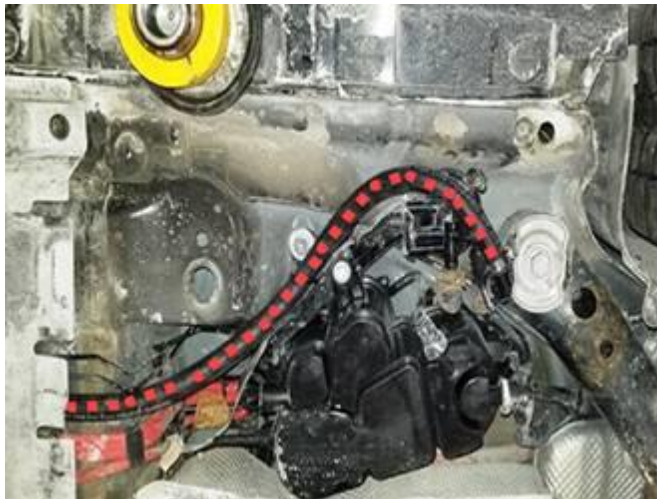
**Figure 8.** Connecting to the J909.

5. Before connecting 5/8" ID rubber hose to 90 degree connector, cut to length, as needed. Connection details to the J909 are shown in Figure 8 and 9.

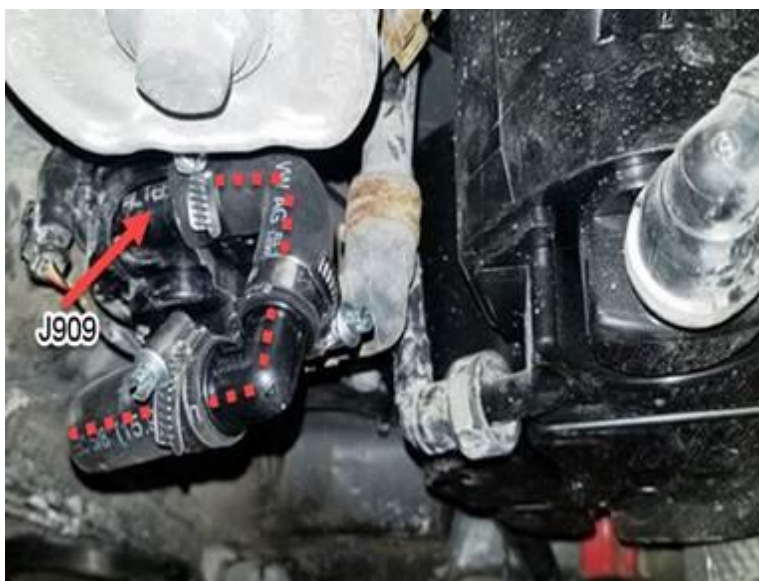
**Figure 9.** Closer look at the connections.

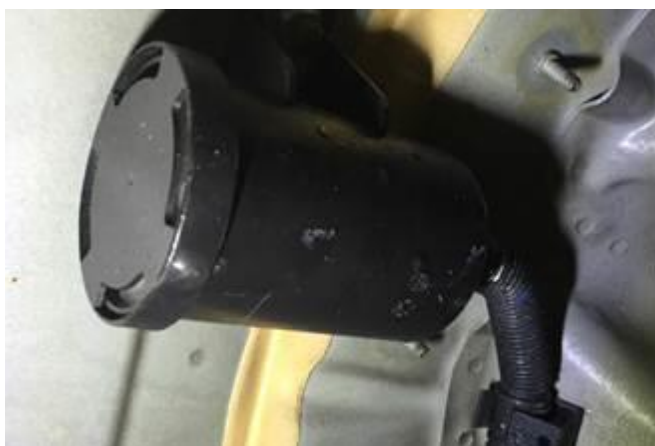
**Figure 10.** Remove original NVLD filter.

6. Remove original NVLD filter assembly. (Figure 10).
