# Technical Service Bulletin

## 37 Transmission malfunction, DTC P17F600, P17F500, P17F400, U008000, and/or U010100 stored in the TCM or ECM

37 19 90 2053878/6 November 8, 2019. Supersedes Technical Service Bulletin Group 37 number 19-89 dated October 22, 2019 for reasons listed below.

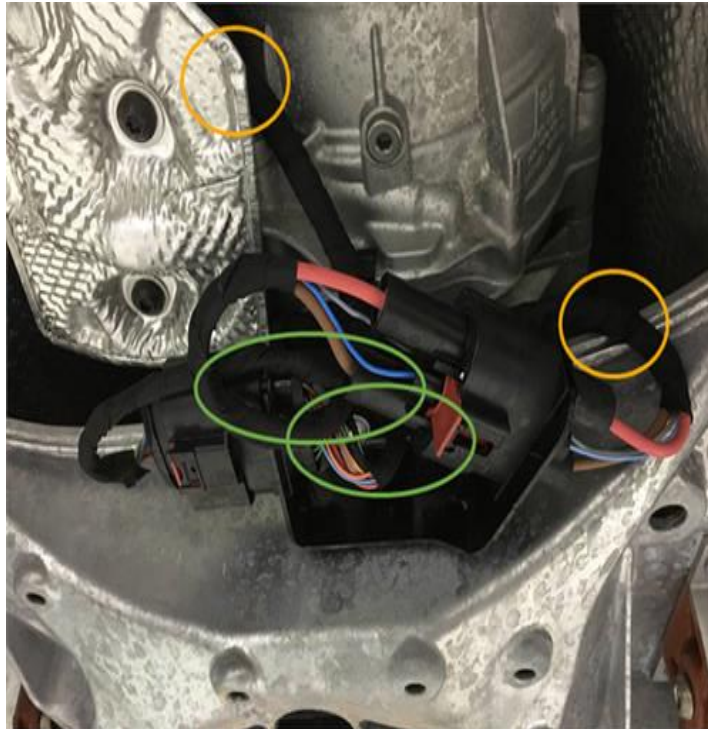
The transmission harness can come in contact with the transmission crossmember and could be damaged.

1. Inspect for damage to the transmission harness (Figures 1 - 4).
  - Thoroughly inspect the transmission wiring harness and routing to determine if the routing is the new or the original concept (Figures 1, 7, and 8).
  - Inspect the body harness and transmission harness for damage near the areas indicated in Figure 1.
  - Harness damage can be very subtle. Even a light chafing of the harness wrap can cause the DTCs.

**Figure 1.** Common areas for harness damage. Also depicted is the original routing concept.

If **transmission harness damage** is found and/or the original routing concept is in place, proceed to step 3.

3. Replace the original transmission harness with a new part and reroute the transmission harness. The transmission harness should not be repaired.
- Remove the original transmission harness in the vehicle.
  - Wrap the exposed wires on the new transmission harness as shown in Figure 7.
  - Mount and route the new transmission harness as shown in Figure 8.

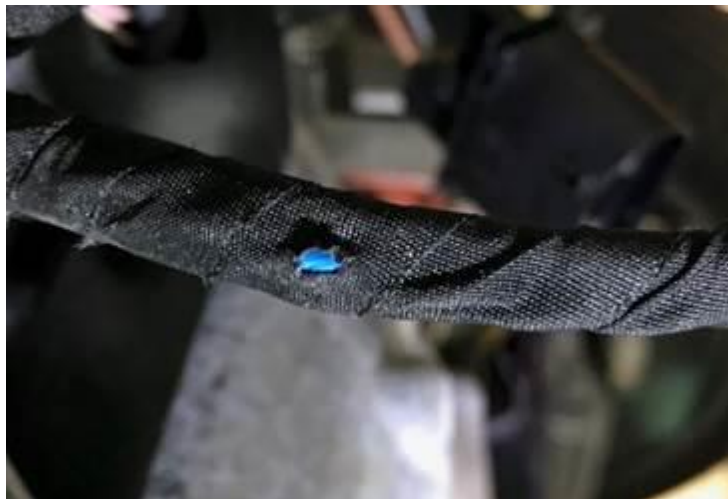
**Figure 2.** Example of a small rip in the protective tape.

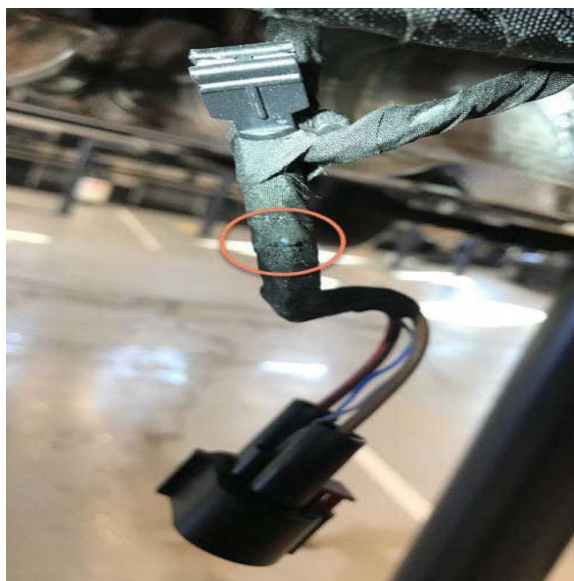
**Figure 3.** The damage on the original harness might be difficult to spot.

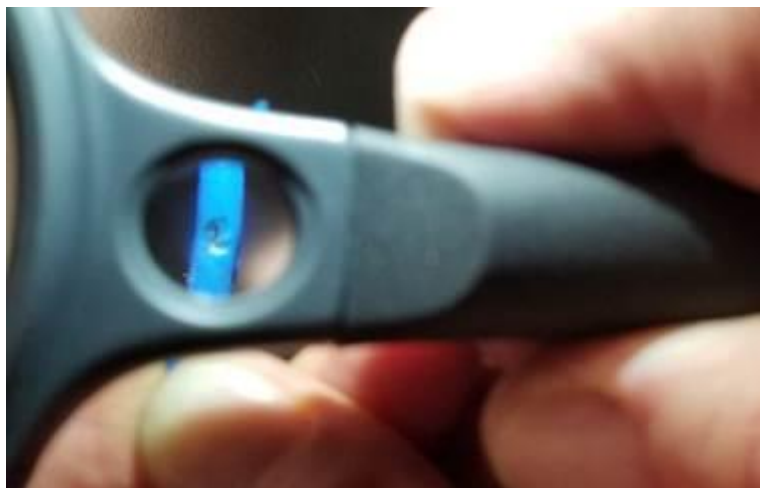
**Figure 4.** The cause of the DTC may be as small as a pinhole.

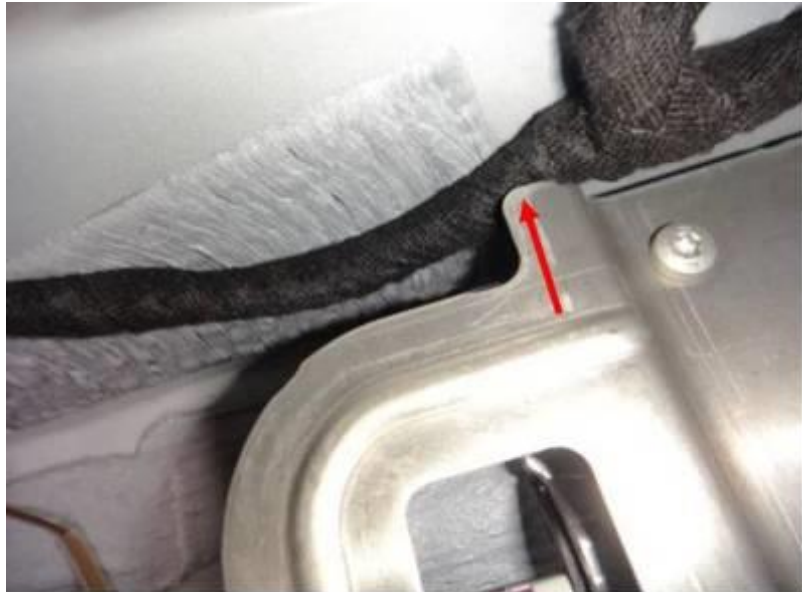
The body harness containing the FlexRay circuit to the transmission may rub against the mounting bracket of the driver assist systems control module, J1121 (address word 00A5).

If there is no damage found and DTC U11B000 (FlexRay data bus branch 2 faulty) is stored, inspect the area shown in Figure 5 and 6.

**Figure 5.** The area where the body harness may rub.

If damage is found in this area then create a TAC case, include photos, and a clear description of your findings.

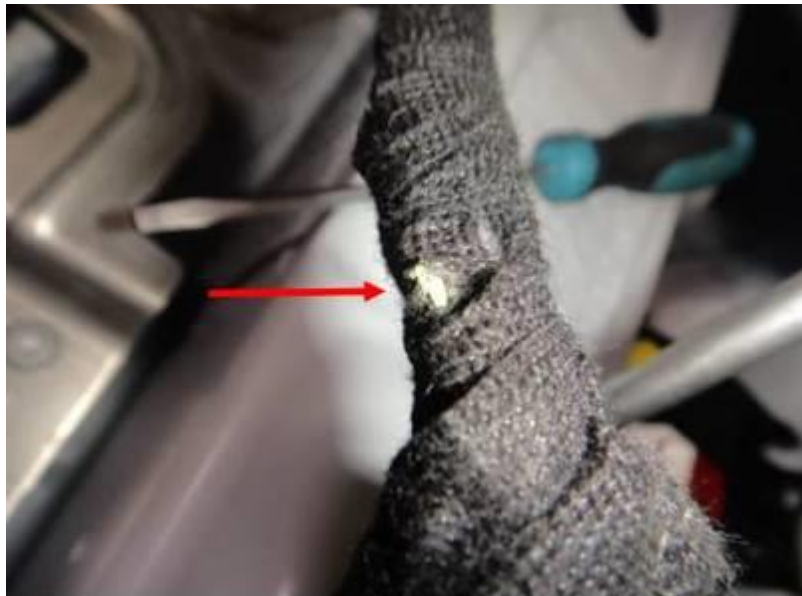
**Figure 6.** Shows the rub mark on the wiring harness.

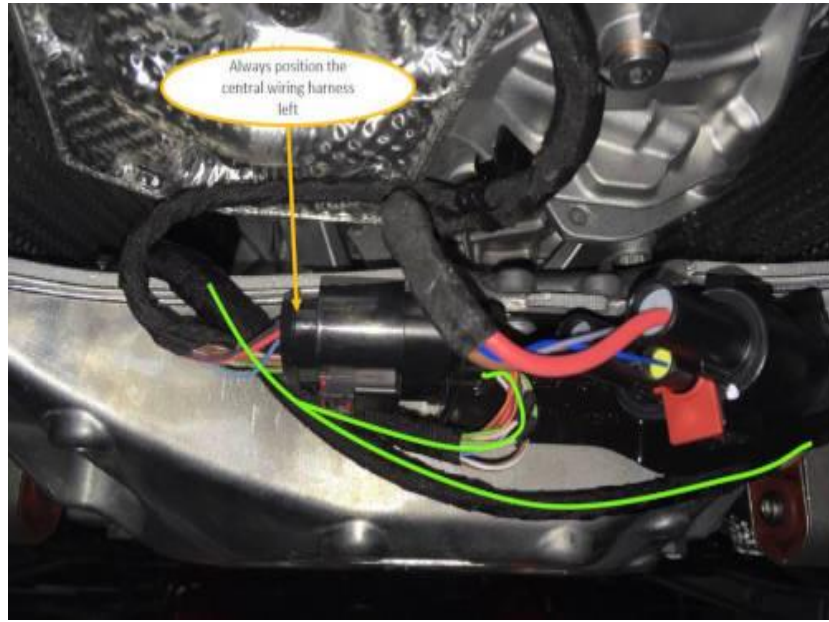
**Figure 7.** New routing and wrapping of the aft part of the transmission harness.

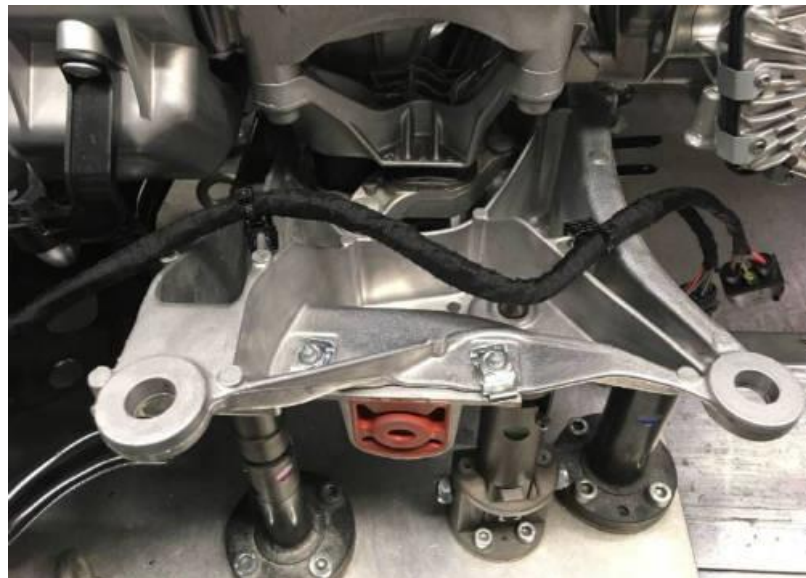
**Figure**

**8.** Routing and mounting of the transmission harness behind the crossmember.

4. The crossmember is shown dismounted in Figure 8 to show the new mounting points more clearly.

For mounting and installation of the new transmission harness, the crossmember does not have to be disassembled.
