# Technical Service Bulletin

## 37 Transmission malfunction, DTC P17F600, P17F500, P17F400, U008000, and/or U010100 stored in the TCM or ECM

37 19 91 2053878/7 November 21, 2019. Supersedes Technical Service Bulletin Group 37 number 19-90 dated November 8, 2019 for reasons listed below.

| Model(s) | Year | VIN Range | Vehicle-Specific Equipment |
|---|---|---|---|
| A6, A7 | 2019 | All | 3.0TFSI |

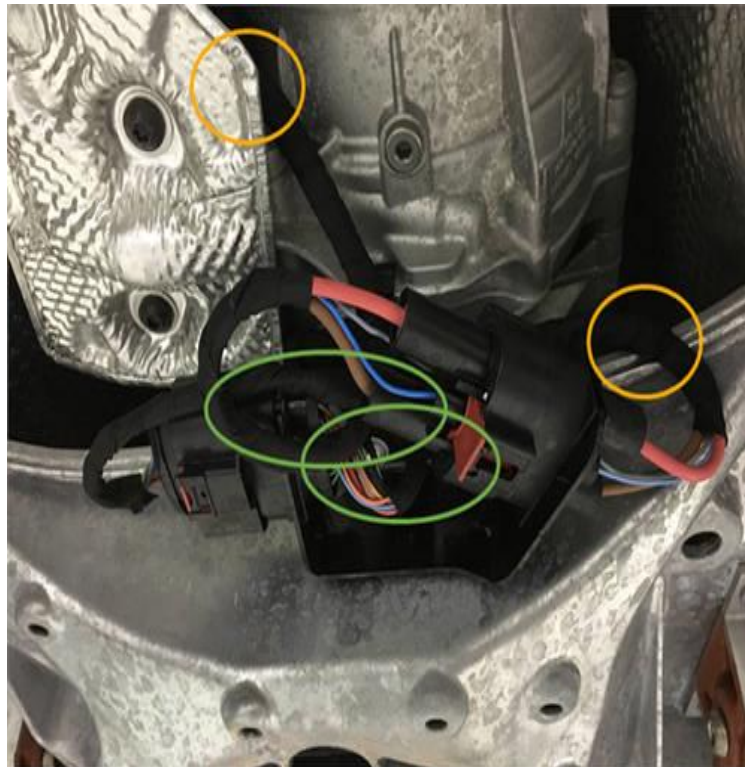
The transmission harness can come in contact with the transmission crossmember and could be damaged.

**Figure 1.** Common areas for harness damage. Also depicted is the original routing concept.

If **transmission harness damage** is found and/or the original routing concept is in place, proceed to step 3.

If **body harness damage** is found regardless of the transmission harness routing, create a TAC case for further instruction. Include photos of the original harness routing, area of damage, close up of damage and a clear description of your findings.

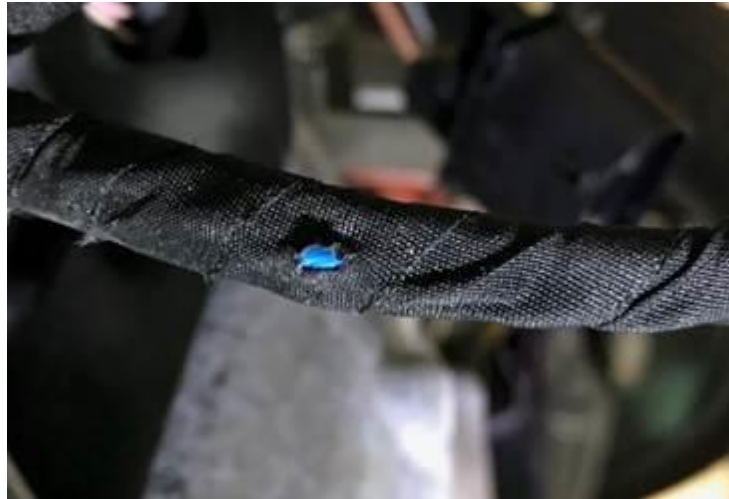
**Figure 2.** Example of a small rip in the protective tape.

3. Replace the original transmission harness with a new part and reroute the transmission harness. The transmission harness should not be repaired.
  - Remove the original transmission harness in the vehicle.
  - Wrap the exposed wires on the new transmission harness as shown in Figure 7.
  - Mount and route the new transmission harness as shown in Figure 8.

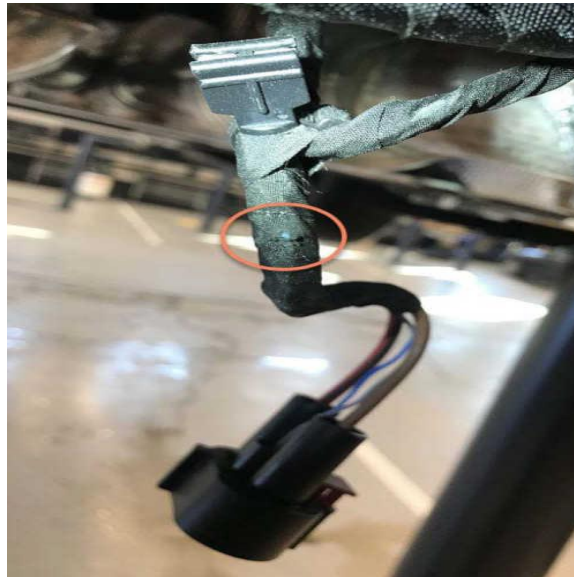
**Figure 3.** The damage on the original harness might be difficult to spot.

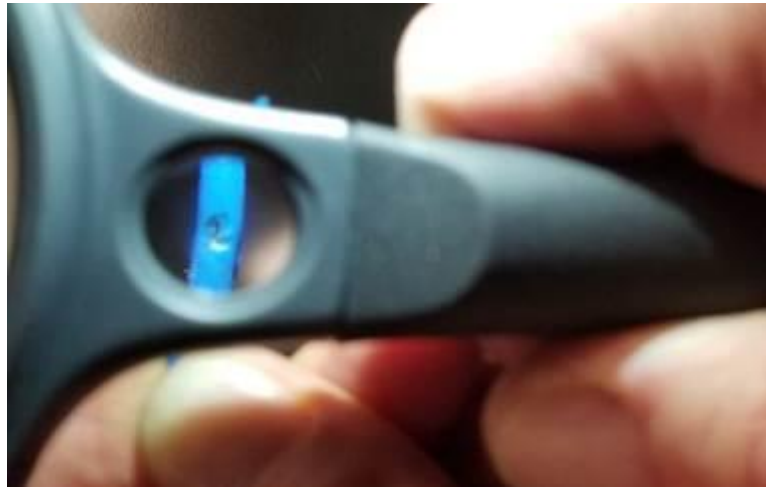
**Figure 4.** The cause of the DTC may be as small as a pinhole.

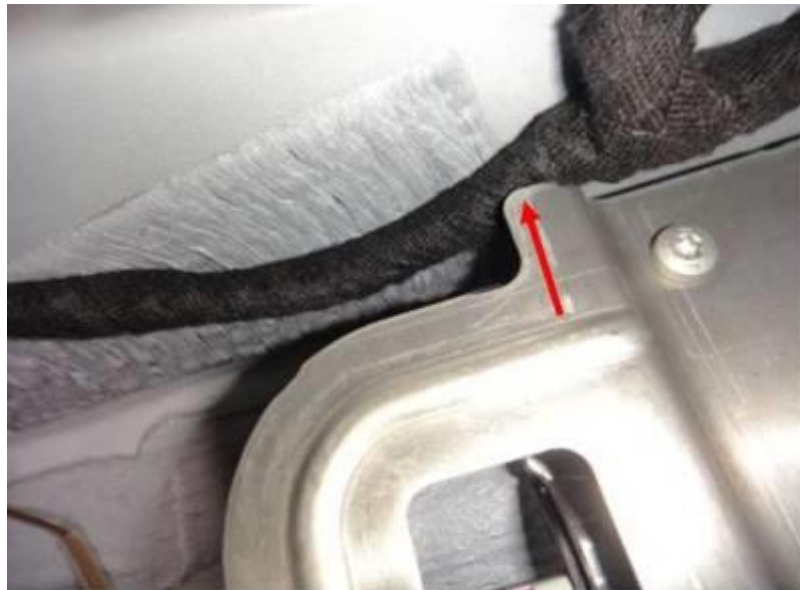
The body harness containing the FlexRay circuit to the transmission may rub against the mounting bracket of the driver assist systems control module, J1121 (address word 00A5).

**Figure 5.** The area where the body harness may rub.

If damage is found in this area then create a TAC case, include photos, and a clear description of your findings.

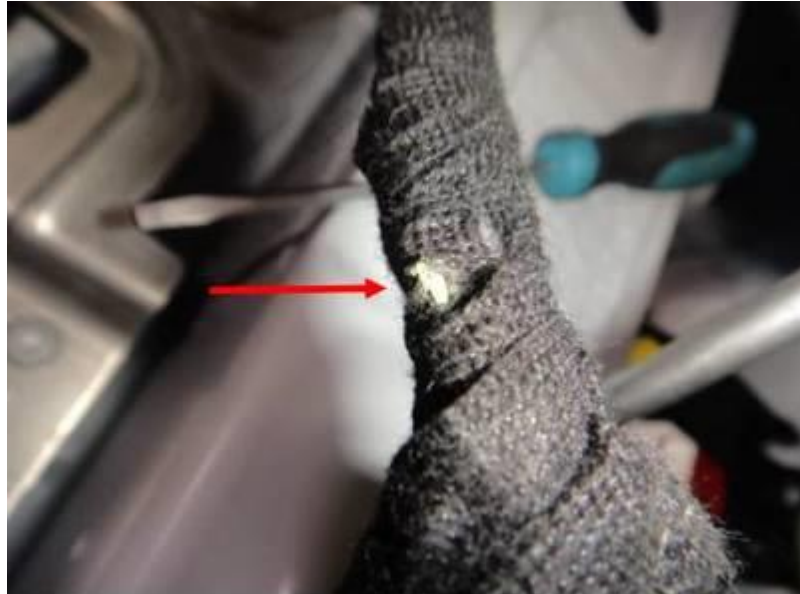
**Figure 6.** Shows the rub mark on the wiring harness.
