# Technical Service Bulletin

**97 MMI display black and/or a parking brake malfunction, DTCs C100C01, U105400, U10B800, U10E200, and/or U10CA00**

97 19 68 2057768/1 November 22, 2019.

| Model(s) | Year | VIN Range | Vehicle-Specific Equipment |
|---|---|---|---|
| A6, A7 | 2019 | All | Not Applicable |

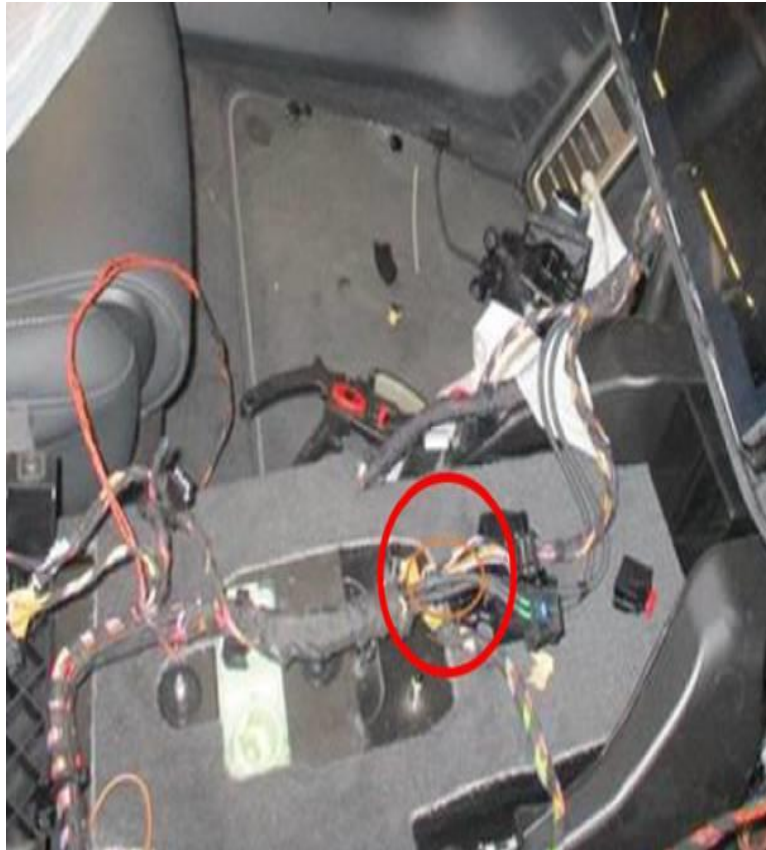
**Figure 1.** Location to inspect underneath center console.

1. Remove the center console according to the repair manual.

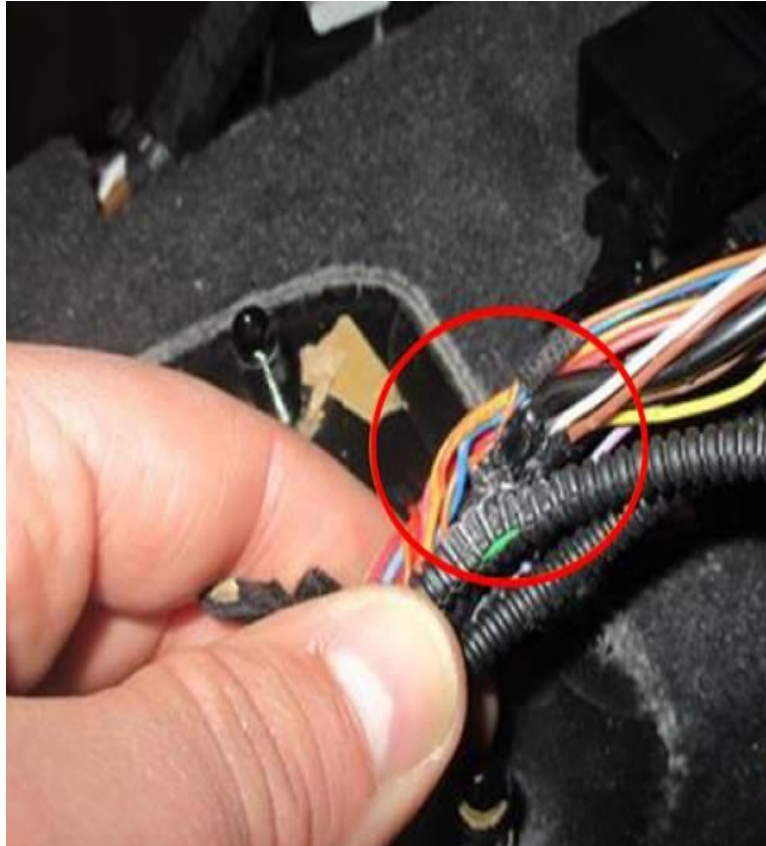
The wire harness underneath the center console may be pinched during assembly.

**Figure 2.** The harness is damaged during assembly.

3. If damage is found as shown in Figure 2, repair the damaged wires using VAS 1978B. Additionally, add the harness protection using the steps below.

4. Once the damaged wires have been repaired with VAS 1978B, wrap the repaired section with the textile tape N 107 209 02.
5. Install the corrugated tube part number N 107 328 01 over the wrapped cables between the red lines indicated in Figure 3.

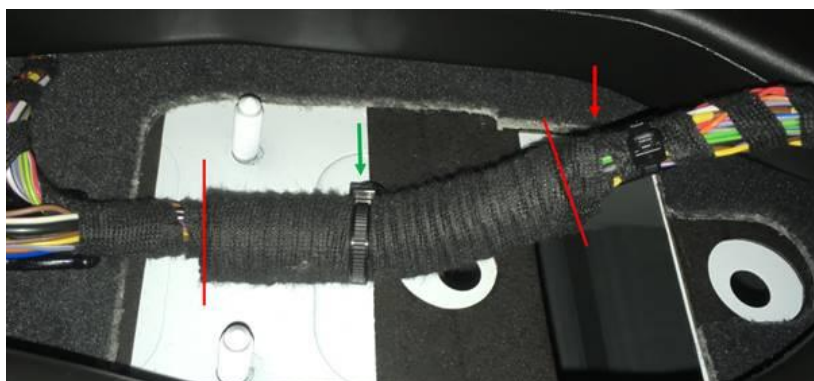
**Figure 3.** Completed harness protection.

6. Using textile tape N 107 209 02, completely wrap the corrugated tube over the harness so that it cannot slip out of place (red arrow on Figure 3).

7. Use a new cable tie, part number **3D0 971 838 A** and secure the harness to the body (green arrow on Figure 3).
8. Once complete, refit the center console according to the repair manual.
