# MPD UPDATE

## Powertrain

| P0234-77 Turbocharger Under boost with a Restricted Performance Message | | 16-18MY equipped with 3.0L TDV6 |

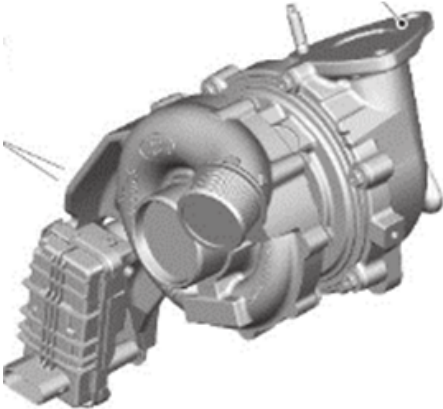
| P0234-77 Turbocharger Under boost with a Restricted Performance Message | | 16-18MY equipped with 3.0L TDV6 |
|---|---|---|
| <p><u>Problem Description:</u></p> <ul style="list-style-type: none"> <li>- TDV6 16-18MYMY3.0L TDV6 equipped vehicles have a MIL and “Restricted Performance” on the instrument cluster and P0234-77 stored in the PCM</li> </ul> <p><u>Current Status:</u></p> <ul style="list-style-type: none"> <li>- Under Investigation</li> </ul> <p><u>Recommended Actions:</u></p> <ul style="list-style-type: none"> <li>- Follow LTB01204, if applicable. If P0234-77 is still stored or the DPF will not regenerate, check if the soot levels decreases. P0234-77 inhibits regeneration. If the DPF cannot be regenerated during a drive or PATHFINDER procedure, raise a Technical Assistance case for further instruction. Should LTS instruct you to replace the DPF, please raise an EPQR.</li> </ul> | | |
