| | GROUP<br><b>Product Improvement</b> | MODEL<br><b>See Model List on Page 1</b> |
| | NUMBER<br><b>PI1802W/X (Rev 6, 11/07/2019)</b> | DATE<br><b>October 2018</b> |
| <b>SUBJECT:</b> ENGINE REPLACEMENT INSTRUCTIONS<br>FOR DTC P1326 (PI1802W/X) | | |

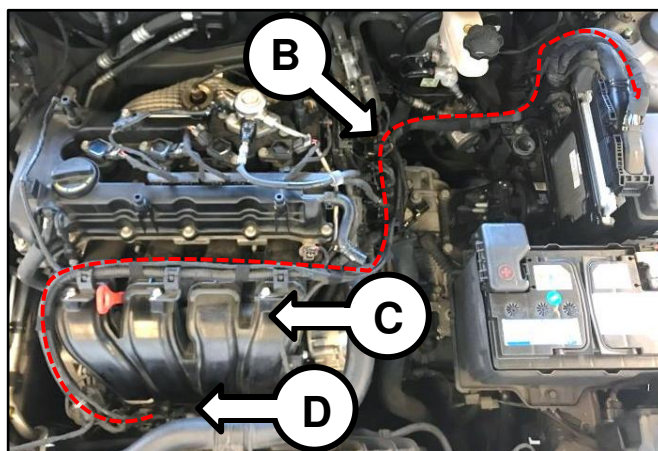
The harness (B) must be routed exactly as shown to prevent related DTCs.

10. Route the extension harness (B) along the existing harness (A) leading by the intake manifold (C) to the knock sensor (D), **exactly** as shown.
