Preliminary Information

PIP5686A Engine Air Leak from The Foul PCV Tube, Whistle Noise, P0171 and/or P0174

Models

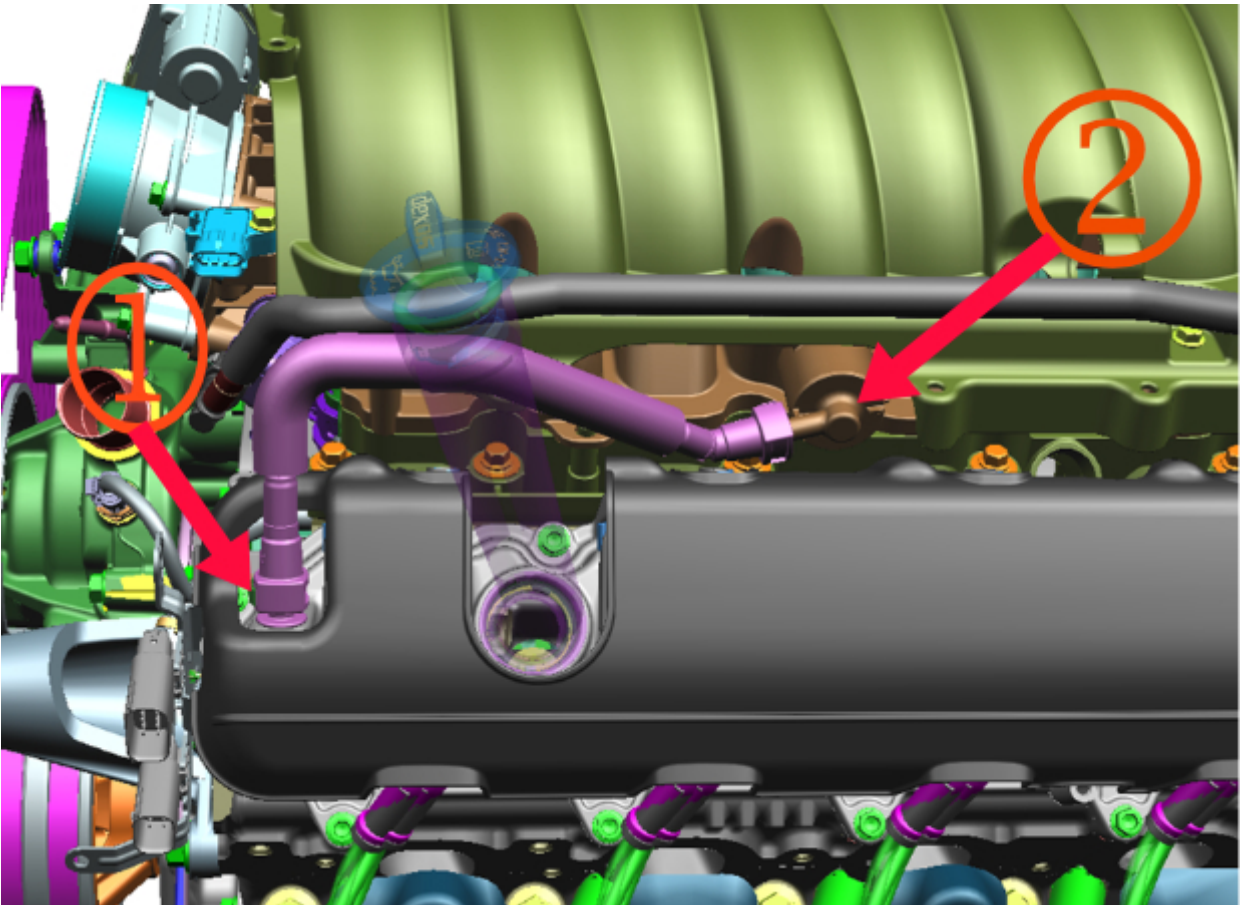
**PCV Tube Locations: Location 1- Connector to Rocker Cover, Location 2- Connector to Intake Manifold**

| Condition | A vehicle may come into the dealer with a rough idle, lean running concern and/or air leak noise from the PCV system. Upon inspection the technician may find the SES lamp is illuminated and/or DTC's P0171 and/or P0174 may be in active or stored history. |
| Cause | This condition may be caused by an incorrectly installed foul air PCV tube or tube may be damaged. |

1. Check to see If tube is installed and seated correctly . If tube is installed correctly it will be necessary to smoke test and confirm there are no leaks. Proceed to the steps below .
  - a. If no smoke is detected, then tug on PCV tube ends (Location 1 or 2) to ensure the tube is seated. If tube was not fully seated, then properly secure connection by pressing tube in until it clicks, and the tube does not come off by pulling on it. Proceed to step 4.
  - b. If smoke is detected, at either at the cover or manifold (Location 1 or 2) Remove and reinstall the same PCV tube to ensure both latches click. Proceed to Step 2.
  - c. If the tube is cracked or other damage in any other location besides (1 or 2) then it will be necessary to remove and replace with a new tube. Proceed to step 4.

2. Repeat smoke test to verify condition is still present. If leak is still p resent at (Location 1 or 2) remove tube and inspect O -ring seals inside, look for damage or missing O-rings. Take images of findings. Replace with new tube if damage is found. Proceed to step 4.
3. Clear the ECU codes.
4. Start vehicle up, idle for 5 minutes in park, shut engine off, repeat (T otal needs to be 2 times)
5. Verify if code/s return:
  - If Yes - if condition is still present or DTC returns, then it will be necessary to follow SI diagnostics in the service manual for that DTC or condition.
  - If No - PCV tube was not correctly seated during assembly . Return vehicle to customer and document findings on repair order .
