# MIL ON With Misfire DTC(s) P0301, P0302, P0303, P0304, P0305, and/or P0306

## Applicability

| YEAR(S) | MODEL(S) | ADDITIONAL INFORMATION |
|---|---|---|
| 2016 - 2019 | RX450H | |

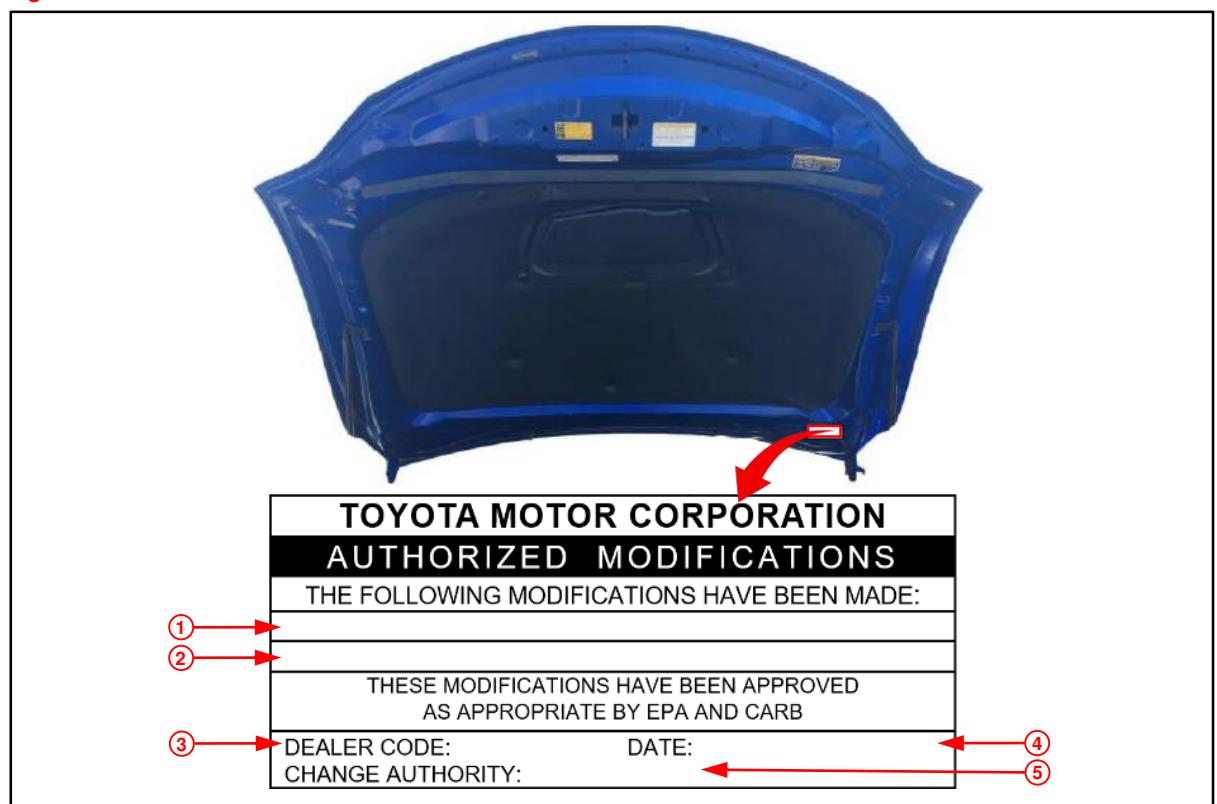
**Figure 1. Location of Authorized Modifications Label on 2016 – 2019 RX450h and 2018 – 2019 RX450hL**

3. Use Techstream to confirm if the ECM (PCM) calibration has been updated and check for the Authorized Modifications Label affixed to the vehicle in the location shown below.

- B. Install the Authorized Modifications Label onto the vehicle at the location shown in Figure 1. The Authorized Modifications Label is available through the MDC, P/N 00451-00001-LBL.
