| <b>HYUNDAI</b><br><b>Technical Service Bulletin</b> | GROUP<br><b>Campaign</b> | NUMBER<br><b>19-01-036H</b> |
| | DATE<br><b>November, 2019</b> | MODEL(S)<br><b>Ioniq (AE)<br/>HEV/PHEV/EV,<br/>Kona (OS) EV</b> |
| <b>SUBJECT</b> ELECTRIC WATER PUMP (EWP) CAN CASE REPLACEMENT<br>- (CAMPAIGN T4G) | | |

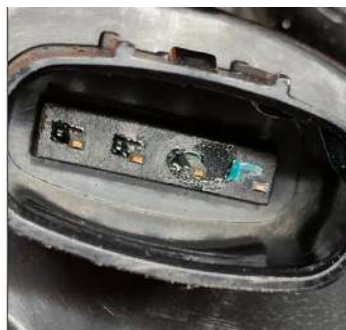
EWP part side

2. Inspect the inside of both connectors of the EWP connection for coolant contamination:
  - **No contamination is found:** Continue to next step 3.
  - **Contamination is found:** Skip to (section-**E**) (page-9) to replace the EWP assembly and (section-**F**) (page-10) vehicle harness EWP connector.

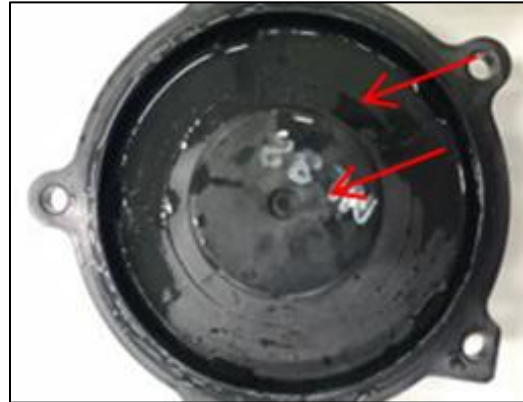
Inspect for evidence of any coolant leak or contamination stains found on the inside of any of the following EWP components:

- **Can Case** (on the side facing the stator):

**NOTE:** If no contamination was found in any of the above 3 components proceed to the next page-8 to replace the Can Case only.

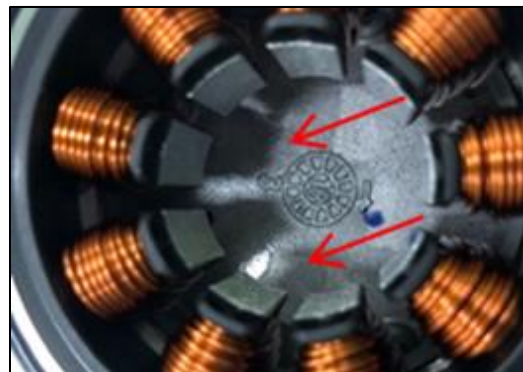
- **Stator:**

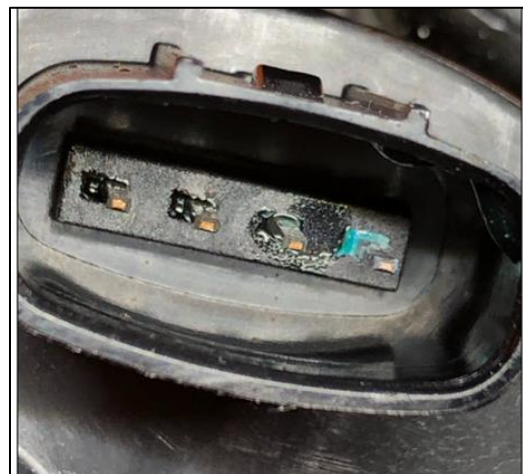
- **Connector:**

The vehicle harness connector must be replaced (section-**F**) (page-10) if contamination is found inside connector.
