| <b>HYUNDAI</b><br><b>Technical Service Bulletin</b> | <b>GROUP</b><br><b>AUTOMATIC TRANSMISSION</b> | <b>NUMBER</b><br><b>19-AT-024H</b> |
| <b>SUBJECT:</b> AUTOMATIC TRANSAXLE DIAGNOSIS (6-SPEED)<br>INHIBITOR/RANGE SWITCH DTC P0705, P0706, P0707 & P0708 | | |

***This TSB supersedes TSB 17-AT-005 to update the Service Procedure and applicable vehicles.***

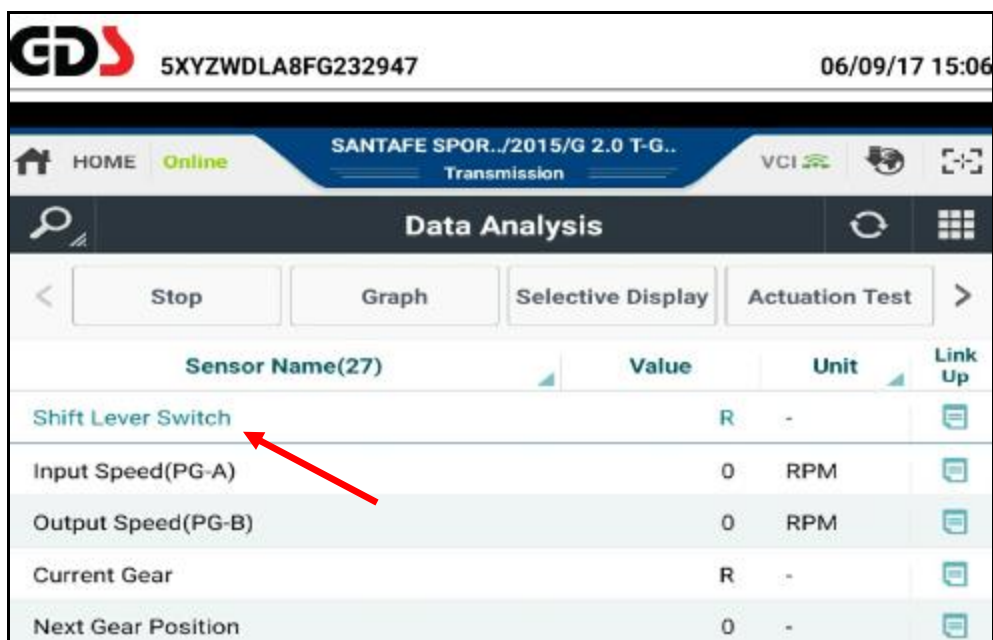
1. Turn the ignition key to the ON position or push the Start/Stop Button two times without depressing the brake pedal.
2. Attach a GDS and check for DTC in the “Automatic Transaxle” menu. **Record the DTC and description.** Delete the DTC.
3. Select **Data Analysis, A/T** menu and **Shift Lever Switch**. Move the shift lever through all gears (P, R, N and D) and monitor the Shift Lever Switch.

4. If the Shift Lever Switch shows:
  - The correct shift lever position, the wiring **currently** has no open/short circuits. Go to Step 6.
  - Does not show the correct shift lever position, go to Step 5.
5. Visually check the wiring harness between the ECU and inhibitor switch for a damaged wire or open circuit/short circuit to ground. Check for a damaged pin or pin not fully inserted into the connector.
  - If damage is found, repair or replace the control wiring and drive the vehicle to confirm the repair.
  - If no damage or open/short circuit is found, go to Step 6.

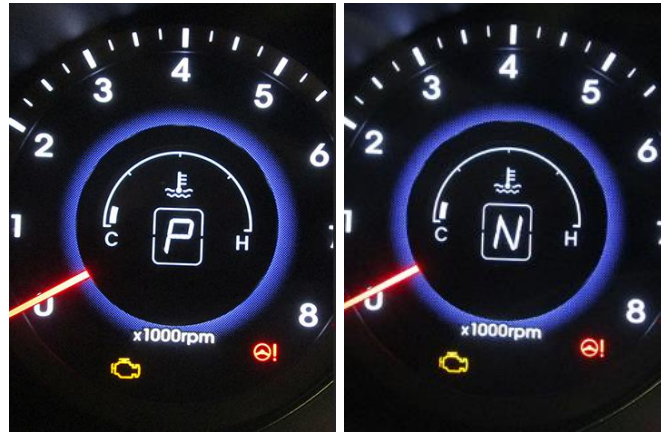
6. Turn the ignition switch to the ON position and place the shift lever in P and N. Confirm the indicator lights in the dash cluster show the correct gear in P and N.
  - If P and N are displayed, go to Step 7.
  - If P or N is not displayed, go to Steps 9 and 15 and check the alignment of the inhibitor switch. Adjust as necessary
  - If P and N are not displayed after adjustment, go to Step 7.

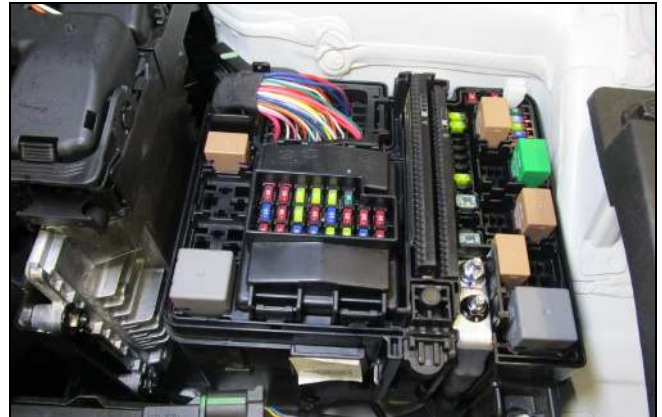
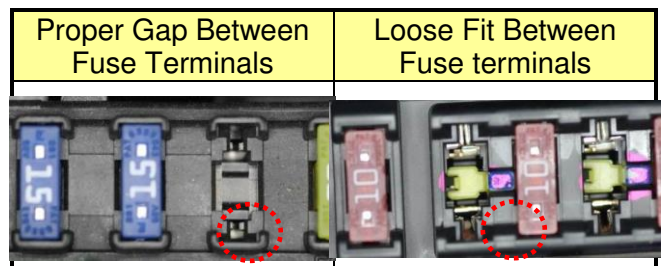
7. Check the TCU and TCU2 fuse in the junction box in the engine compartment:
  - Check the fuse for an open circuit.
  - Check the fuse for correct capacity.
  - Check the fuse holder for a tight fit.
  - Check for loose or damaged wires.

If damage or intermittent open circuit is found, repair or replace the junction box and front harness.

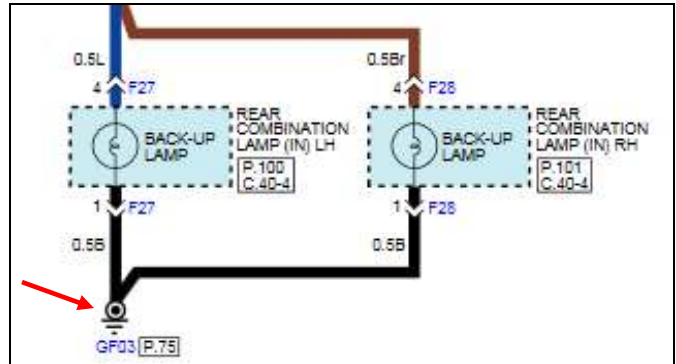
8. Check the rear combination lamp ground for tightness.

Turn the ignition and headlights on. Use a DVOM to check the voltage drop between the combination lamp wiring terminal and ground.

**Specification: Less than 0.2 V.**

- If more than 0.2V, clean the terminal and bolt threads and tighten the bolt.
- If less than 0.2V, go to Step 9.
