# Service Alert

## DTC U2050:55 STORED AFTER BCM SOFTWARE UPDATE

**Service Alert No.: SA-055/19****Last Issued: 12/10/2019****APPLICABLE MODEL(S)/VINS**

2019 Mazda3

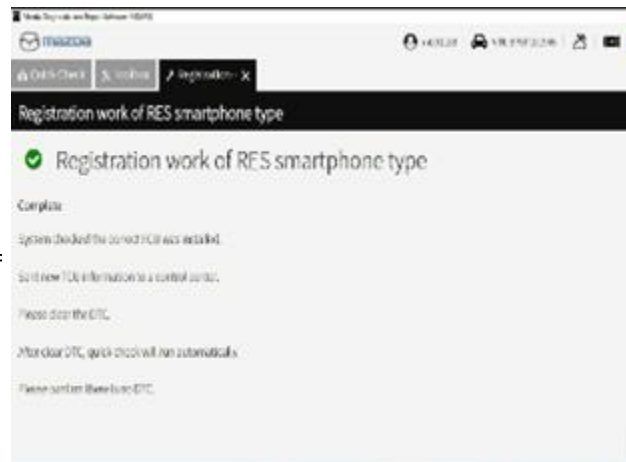
Registration work of RES smartphone type

System is checking the correct SDK was installed

Process is running: 50%
