# Technical Service Bulletin

## 20 MIL on or difficulty refueling, DTC P045100, P044100, P202500, and/or P045300 stored in the ECM

20 19 24 2050276/4 December 18, 2019. Supersedes Technical Service Bulletin Group 20 number 19-23 dated November 15, 2019 for reasons listed below.

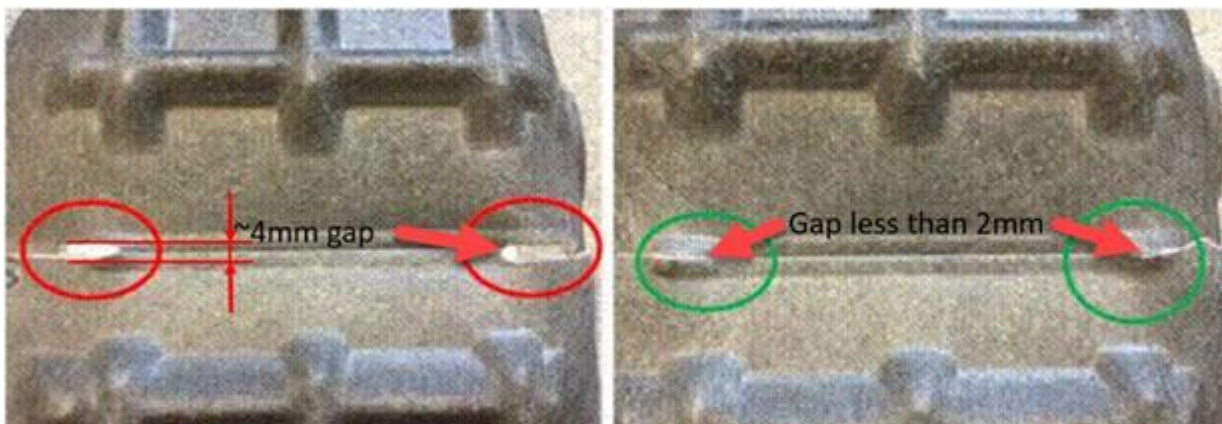
**Figure 1.** How to determine which steps to take Version 1 (~4mm gap) or Version 2 (gap less than 2mm).

1. If the updated wheel liner has not yet been installed. Then install the updated wheel liner, which has closed slots around the NVLD filter.
  - Remove the EVAP canister, ventilation tube, and NVLD pressure switch.
  - Remove all components mounted on the EVAP canister.

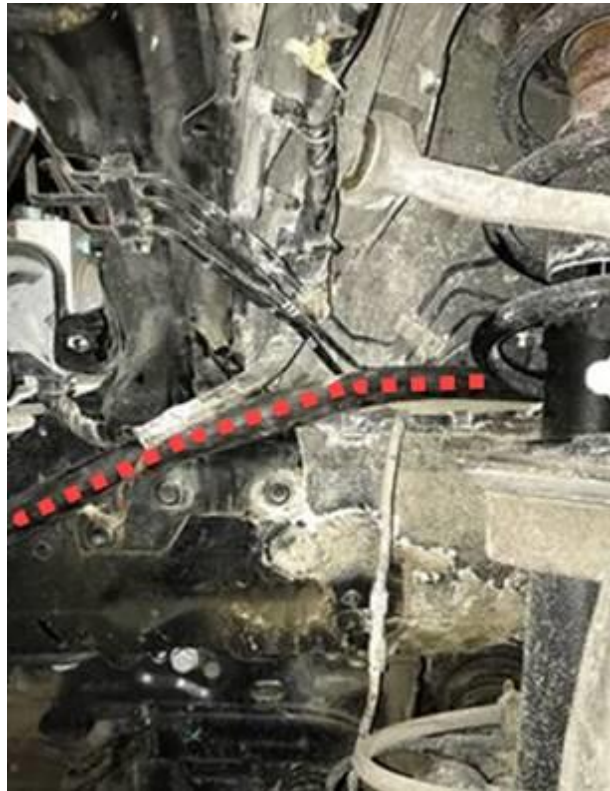
**Figure 5.** Route the 5/8" ID rubber hose from new filter position to the J909.

3. Route the 5/8" ID rubber hose behind the strut and brake lines from new filter position to the J909, along the orange battery cable (Figure 5 and 6). Then secure with zip ties.

5/8" ID rubber hose needs to be routed in a way that there are no sharp bends to prevent kinking.

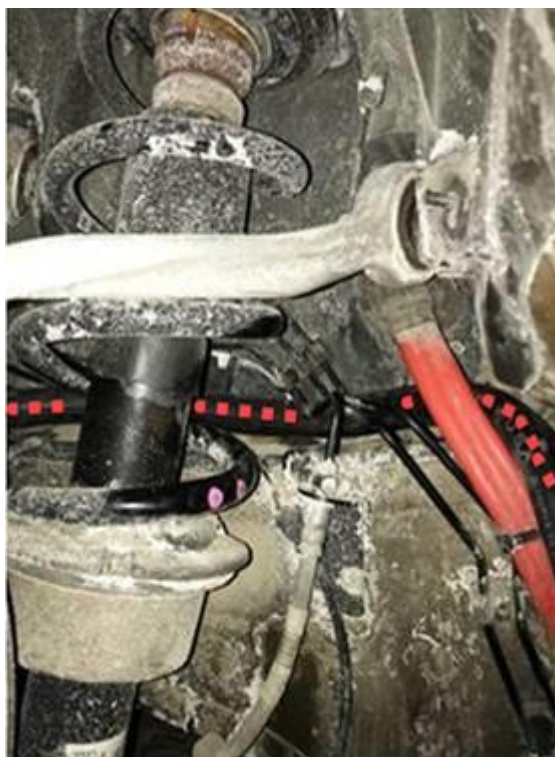
*Figure 6. Routing the rubber hose.*

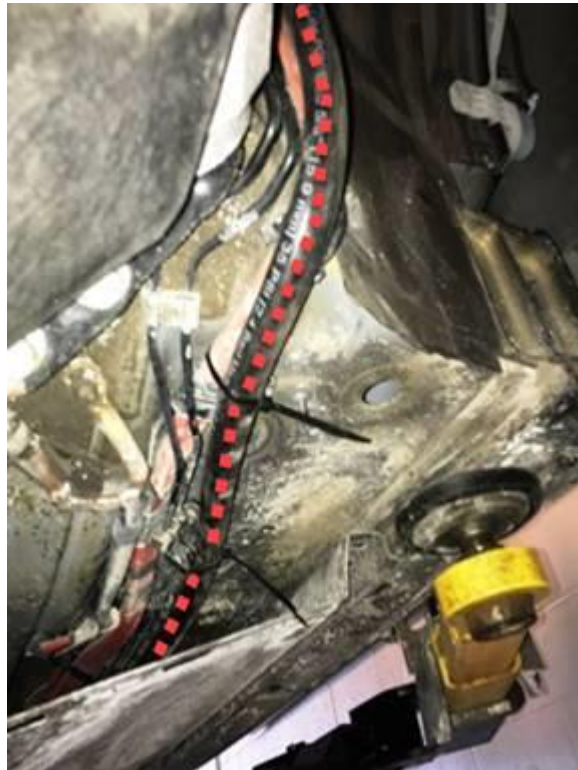
**Figure 7.** Where to zip tie the rubber hose to the battery cable.

- Routing details to the J909, along the
4. orange battery cable. Add zip-ties every 12 inches (Figure 7).

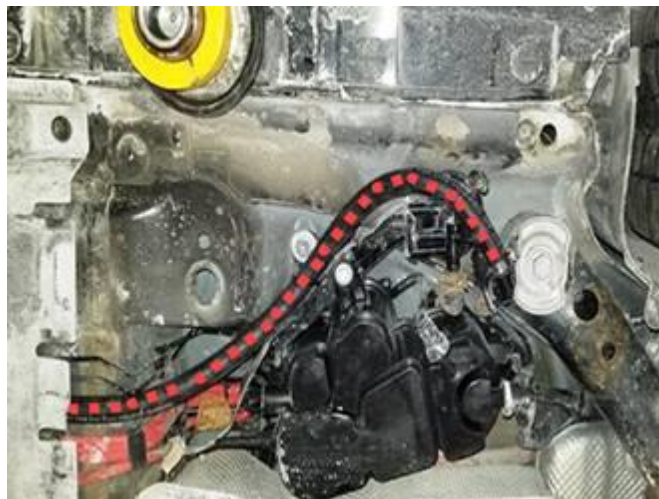
**Figure 8.** Connecting to the J909.

5. Before connecting 5/8" ID rubber hose to 90 degree connector, cut to length, as needed. Connection details to the J909 are shown in Figure 8 and 9.

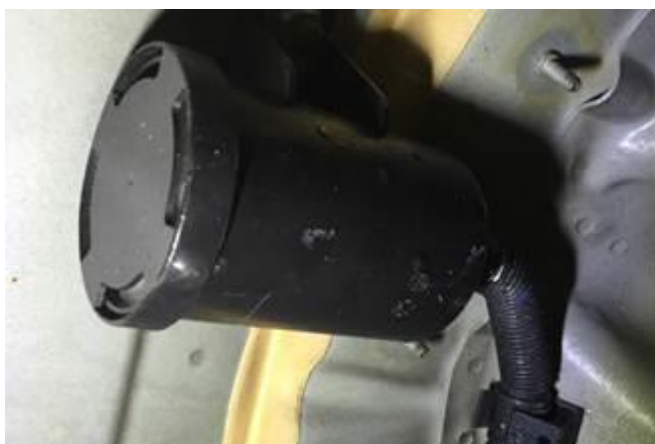
**Figure 10.** Remove original NVLD filter.

6. Remove original NVLD filter assembly. (Figure 10).
