# Technical Service Bulletin

**"AUTO LIGHT SYSTEM MALFUNCTION. TURN ON/OFF LIGHTS MANUALLY" WARNING MESSAGE AND DTC B10AD:09 STORED WHEN PARKED DURING HOT WEATHER CONDITIONS**

**Bulletin No.:** 09-036/19

**Last Issued:** 12/17/2019

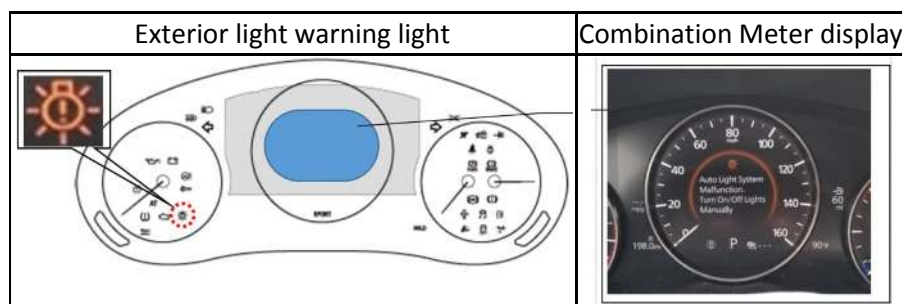
Some customers may complain about an instrument cluster warning message "Auto Light System Malfunction. Turn On/Off Lights Manually". DTC B10AD:09 (Humidity sensor/solar radiation sensor/auto light sensor/rain sensor malfunction) may also be stored with the exterior light warning indicator light ON.

This is caused by the rain sensor detecting a temperature higher than the operation range and temporarily stopping the auto light system. As a fail-safe, the low beam headlights are turned on. The auto light system will start to operate normally when the A/C is turned on and the interior temperature drops. To correct this concern, the heat resistance performance of the rain sensor has been enhanced.

1. Verify customer concern.
2. Replace the rain sensor with a modified one according to the instructions on MGSS (RAIN SENSOR REMOVAL/INSTALLATION).
3. Verify repair.
