# Technical Service Bulletin

**97 MMI display black and/or a parking brake malfunction, DTCs C100C01, U105400, U10B800, U10E200, and/or U10CA00**

97 19 69 2057768/2 December 20, 2019. Supersedes Technical Service Bulletin Group 97 number 19-68 dated November 22, 2019 for reasons listed below.

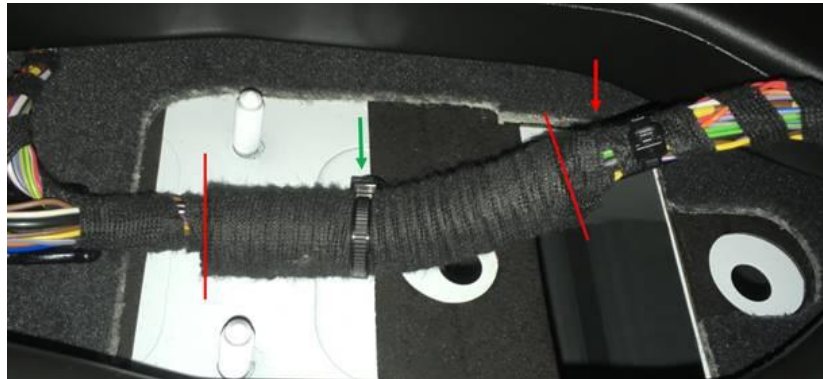
**Figure 3.** Completed harness protection.

4. Once the damaged wires have been repaired with VAS 1978B, wrap the repaired section with the textile tape N 107 290 02.
5. Install the corrugated tube part number N 107 328 01 over the wrapped cables between the red lines indicated in Figure 3.

6. Using textile tape N 107 290 02, completely wrap the corrugated tube over the harness so that it cannot slip out of place (red arrow on Figure 3).

7. Use a new cable tie, part number **3D0 971 838 A** and secure the harness to the body (green arrow on Figure 3).
8. Once complete, refit the center console according to the repair manual.
