December 20, 2019

## MIL Comes On with DTC P0430 or DTC P0430 with P030X, P219A, P219B (With Software Update)

Supersedes 19-072, dated July 5, 2019, to revise the information highlighted in **yellow**

This bulletin replaces 17-036, *MIL Comes On with DTC P0430 (Front Bank Catalyst System Efficiency Below Threshold [Bank 2])*.

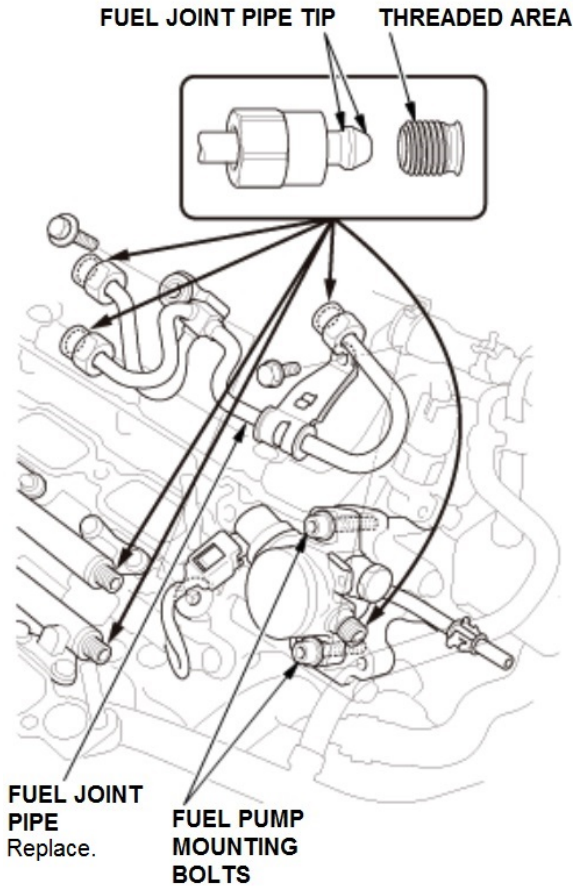
Do not reuse the fuel joint pipe. Failure to install a new fuel joint pipe will cause fuel leaks.

2. Install the parts in the reverse order of removal. Refer to the service information.
  - 2.1. Install the fuel injectors to the fuel rail.
  - 2.2. Install the fuel rail and fuel injectors to the cylinder head.
  - 2.3. Lubricate the tips of the new fuel joint pipe with polyethylene glycol (included in the fuel joint pipe kit).
  - 2.4. Also, lubricate the threaded areas of the fuel rails and high pressure fuel pump with polyethylene glycol.

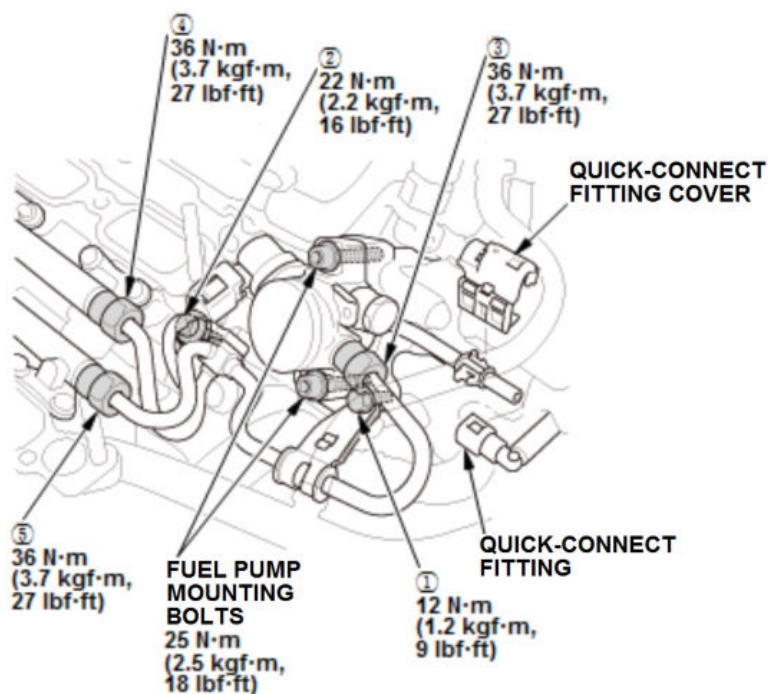
- A crowfoot-type tool increases the torque applied by the torque wrench. Refer to the procedure, Torque Specifications in the service information for details on how to recalculate the torque wrench setting.
- Failure to tighten the fuel joint pipe nuts to the proper torque will cause a fuel leak.

- 2.8. Tighten the fuel joint pipe bracket bolts to **12 N·m (9 lb·ft)** and **22 N·m (16 lb·ft)** as shown.

2.9. Tighten the fuel joint pipe nuts to **36 N·m (27 lb-ft)** as shown.
