## Technical Service Bulletin

| Topic | TPMS Warning light - DTC U012700 evident |
| Brand | Bentley |
| Transaction No. | 2057947/2 |

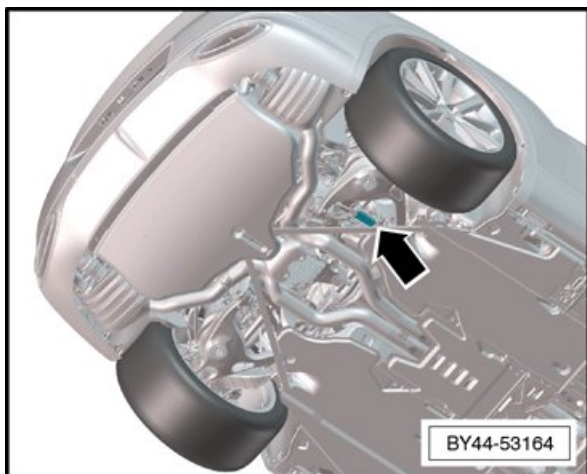
Figure 1

Tyre pressure monitoring system warning light on within the DIP

DTC U012700 evident within Address 0019 Gateway

1) Replace the Tyre pressure control module and bracket (Figure 1) - Refer to Rep.Gr 44

The control module and bracket should be returned back to Bentley Motors Crewe as a complete assembly using the normal parts return procedure

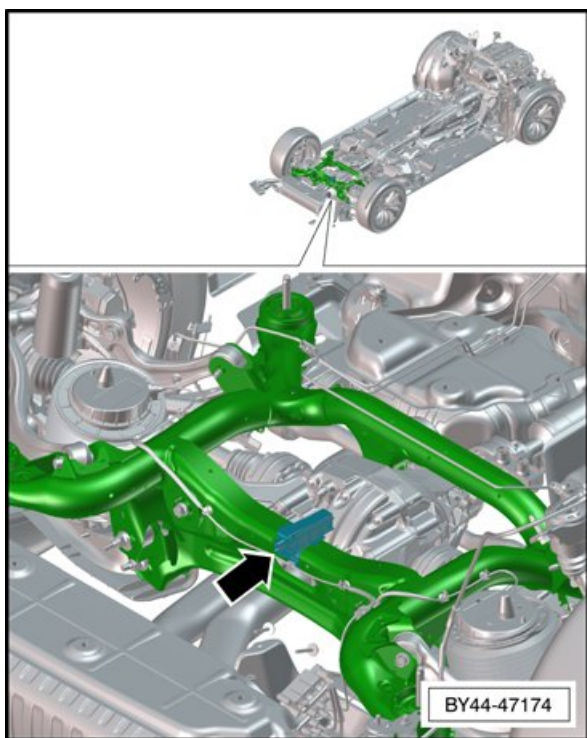
NOTE: For clarity Figure 1 shows the fitting location for the New Continental GT, New Continental GTC and New Flying Spur, Figure 2 shows the fitting location for Bentayga
