| <b>HYUNDAI</b><br><b>Technical Service Bulletin</b> | GROUP<br><b>CAMPAIGN</b> | NUMBER<br><b>19-01-046H</b> |
| | DATE<br><b>DECEMBER, 2019</b> | MODEL(S)<br><b>PALISADE (LX2)</b> |
| <b>SUBJECT:</b> BLIND-SPOT COLLISION WARNING (BCW) RADAR UPDATE<br>(SERVICE CAMPAIGN T4K) | | |

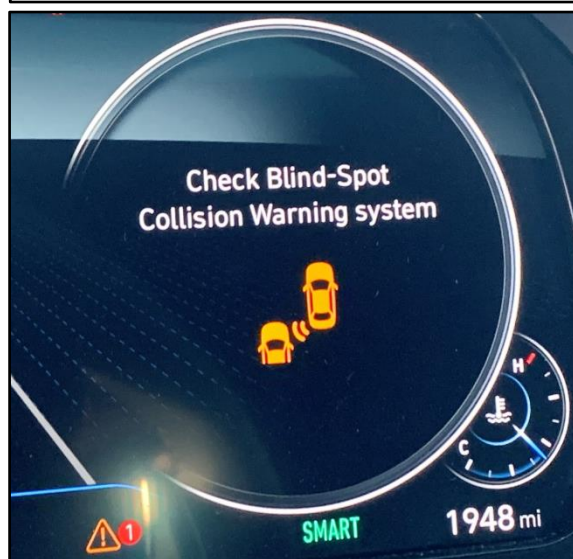
#### BCW Malfunction Indicator Message

**Description:** Some Palisade (LX2) vehicles may intermittently experience the BCW Malfunction Indicator Light ON with a message "Check Blind-Spot Collision Warning System" displayed on the instrument cluster. When the BCW Malfunction Indicator Light is ON, the BCW function becomes inoperative. This bulletin provides the service procedure to update the BCW system software to correct the intermittent BCW Malfunction Indicator Light.

**NOTE:** When the BCW Malfunction Indicator Message turns ON, the diagnostic code C270354 (Control Module Slave Calibration) will be triggered.
