# Service Alert

**INSTRUMENT CLUSTER WARNING MESSAGE "SAFETY AND DRIVER SUPPORT SYSTEMS PARTIALLY DISABLED" AND DTC U0401:68 IS STORED**

**Service Alert No.:** SA-008/20

2019 Mazda3

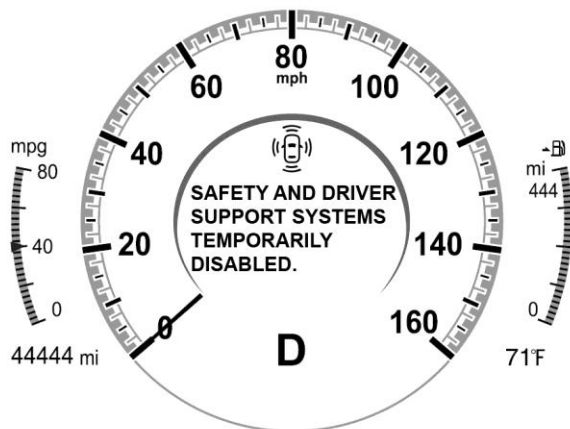
Some customers may experience an instrument cluster warning message "Safety and Driver Support Systems Partially Disabled" and DTC U0401:68 [VEHICLE CONTROL MODULE (US)] (Error signal received from PCM, DSC HU/CM, instrument cluster, or body control module (BCM)) stored. This may be caused by the customer riding the brake pedal.

1. Verify customer concern.
2. Perform MDARS VCM software update.
3. Erase any DTC's if stored.
4. Verify repair.
