## SERVICE BULLETIN

EC19-018b

NTB19-045b

### MIL ON WITH DTC P0087, P0101, P0448, OR P2008, VEHICLES REGISTERED OUTSIDE OF CALIFORNIA

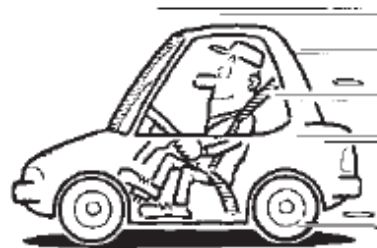
Figure 1

- Connect a battery maintainer or smart charger set to reflash mode or a similar setting. If the vehicle battery voltage drops below 12.0V or above 15.5V during reprogramming, the ECM may be damaged.
- Be sure to turn OFF all vehicle electrical loads. If a vehicle electrical load remains ON, the ECM may be damaged.
- Be sure to connect the AC Adapter. If the CONSULT PC battery voltage drops during reprogramming, the process will be interrupted and the ECM may be damaged.
- Turn OFF all external Bluetooth® devices (e.g., cell phones, printers, etc.) within range of the CONSULT PC and the VI. If Bluetooth® signal waves are within range of the CONSULT PC during reprogramming, reprogramming may be interrupted and the ECM may be damaged.
