# Preliminary Information

## PIC5903C Spark EV Chevrolet Volt Opel Ampera Models With Or Without Service Vehicle Soon Lamp - SVS - or Check Engine Lamp On With DTC P0534 Set Current Or History

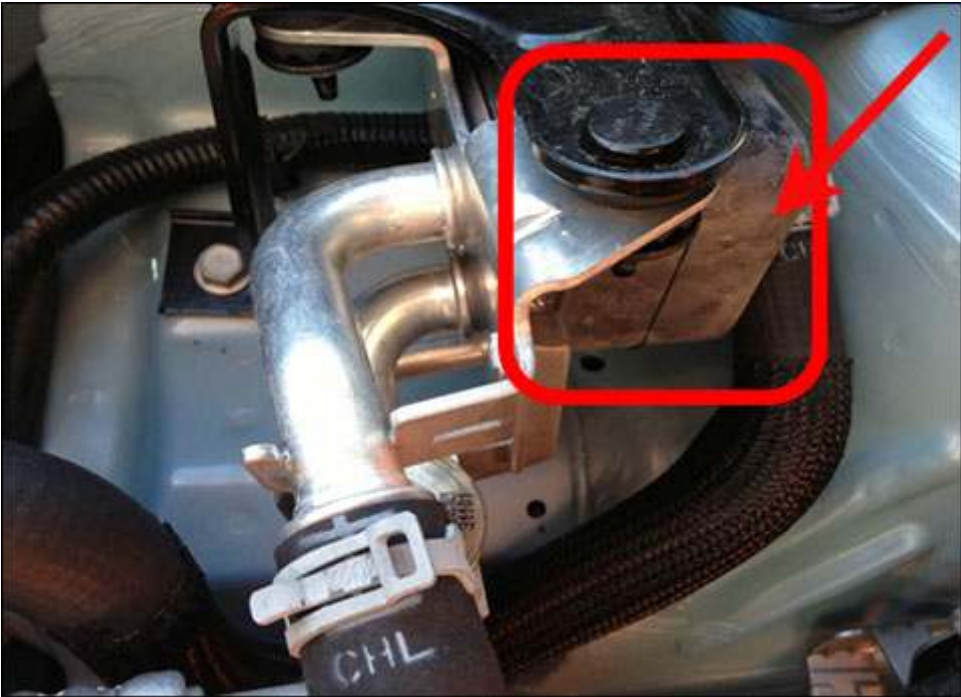
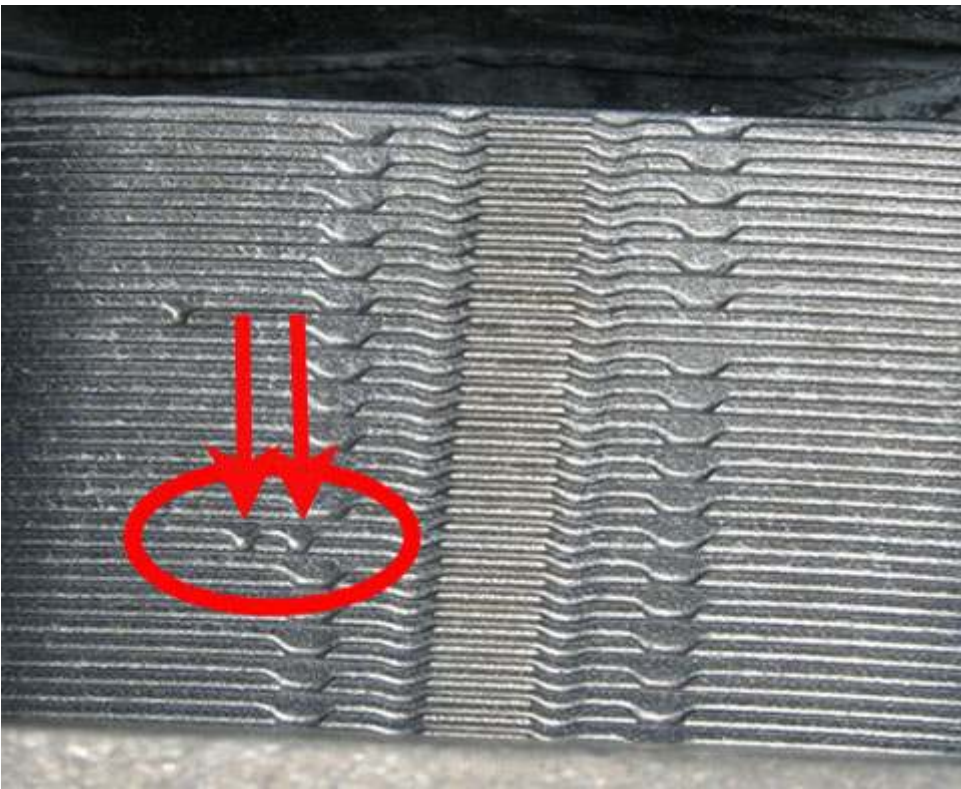
A. **Shown below is a picture of the RESS Cooler from the Spark EV. The black insulator cover can be easily pulled back to inspect the Cooler Plate notches without removal.**

For Volt and Ampera models the inspection remains the same once the RESS Cooler has been removed from the vehicle.

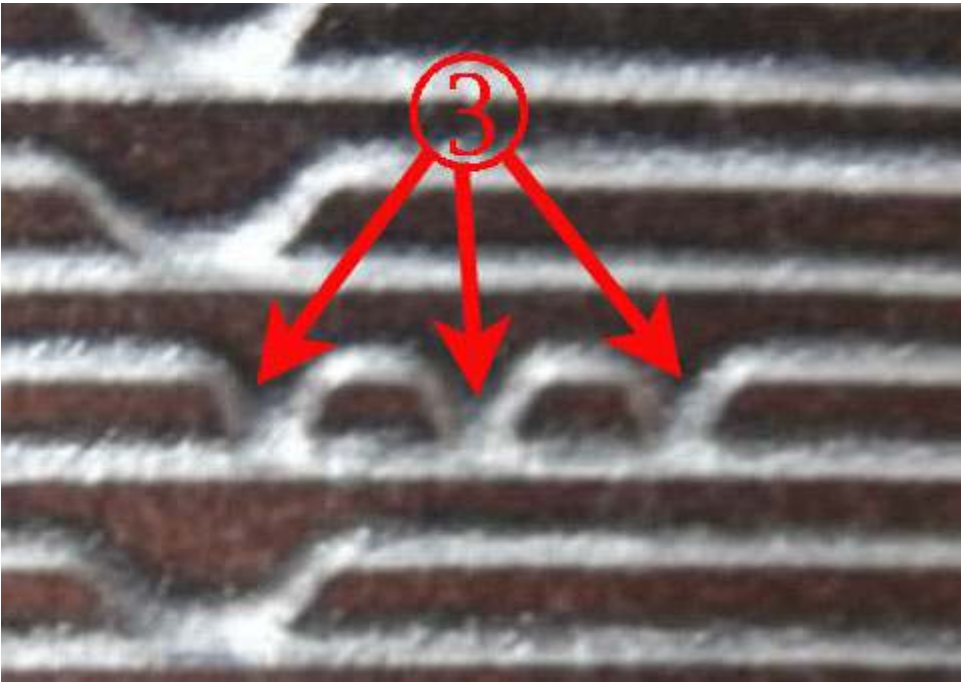
3 Notches equals replace cooler.

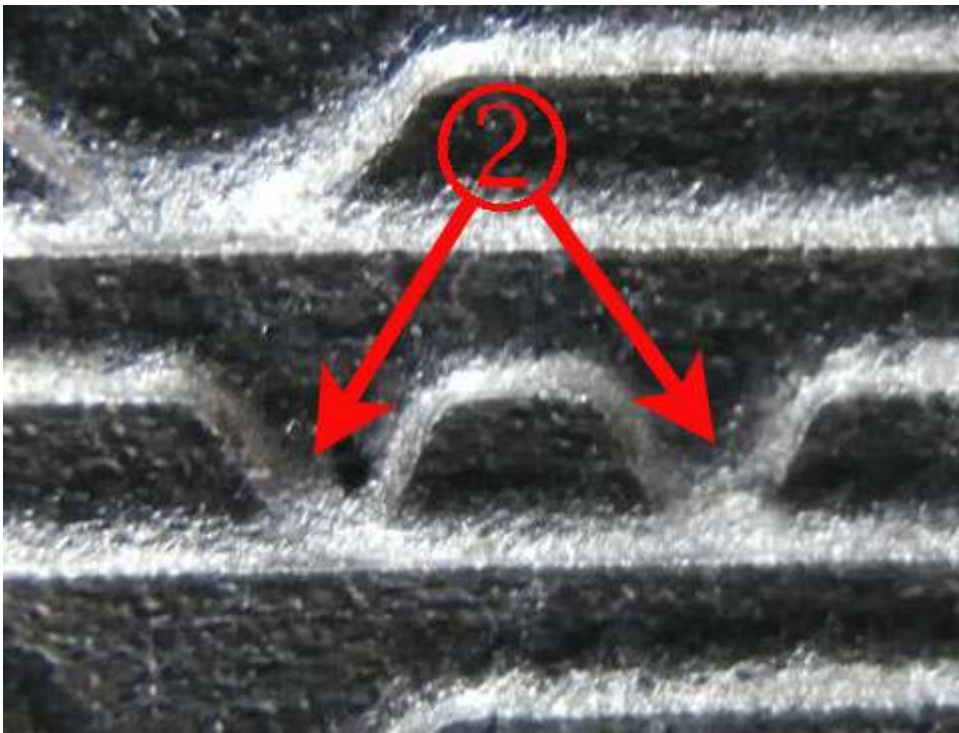
**2 Notches equals DO NOT replace cooler.**
